**Number:** TSB-FC-2016-253 Focus II Rider  
IC650 Charger Interlock Failure

**Date:** 2nd March 2016

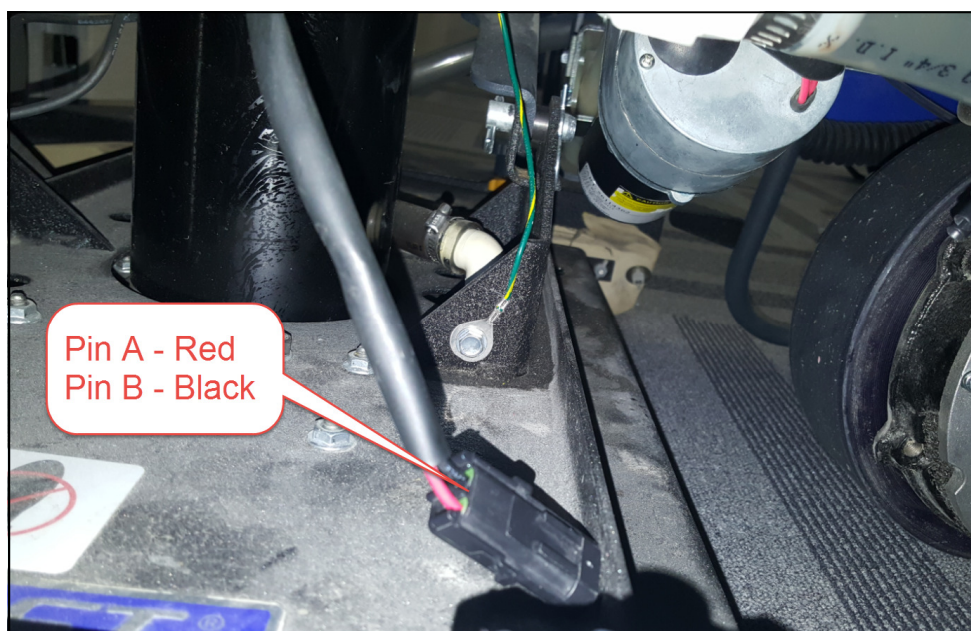
If the charger interlock circuit has failed, please check the amp draw of the actuator installed in the machine to verify the actuator and linkage are functioning normally. Please test the amp draw of the actuator when jumped directly to the battery. It should be drawing between 2 -3 amps when raising and lowering. Pin A and Pin B of the actuator connector are for the motor (FIG.1). Reverse polarity to change direction.

After verifying the actuator (PN 56114362) is functioning normally, replace the User Interface Panel and Onboard Charger.
