## TECHNICAL SERVICE BULLETIN

**Number:** TSB-FC-2016-252 CS7000 Steering boot

**Symptom:** Loss of steering

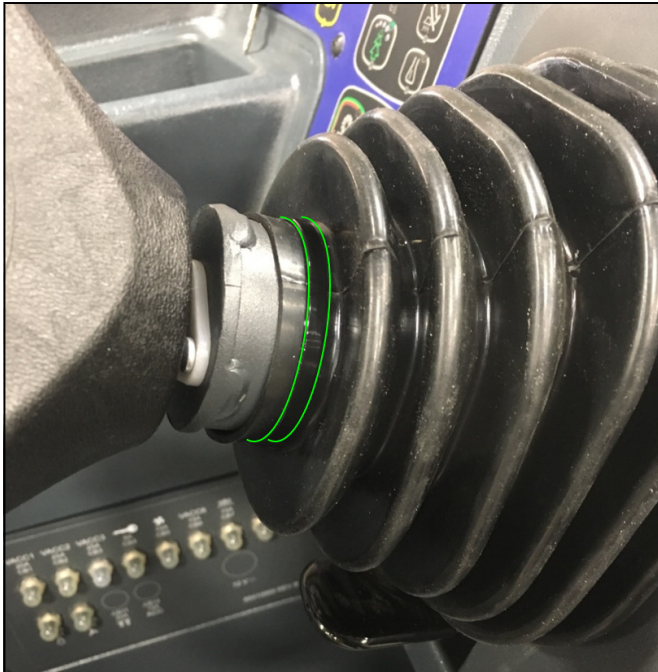
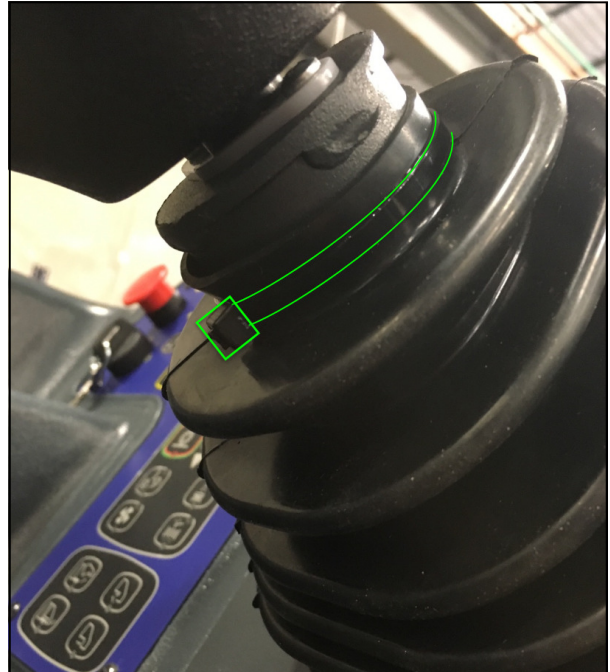
**COMPONENT LOCATIONS / PICTURES:**

The rubber steering boot has a slip fit onto the steering shaft and may allow water to intrude and leak into the TFD (Torque Feedback Device) causing corrosion and premature failure. Washing this area may allow water to enter into the TFD.

Water ingress between the steering boot and the shaft and eventually into the TFD leading to failure.

Install TY WRAP (2-00-04345) around the top of the steering boot to prevent water from entering. See photos below.

**2-00-04345** TY-RAP THOMAS+BETTS-TY-28M around top of steering boot to prevent water ingress.
