**Number:** TSB-FC-2016-250 SC6500 Drive  
Harness Routing

**Symptom:** Machine will not move forward or  
reverse

**Date:** 18th Feb. 2016

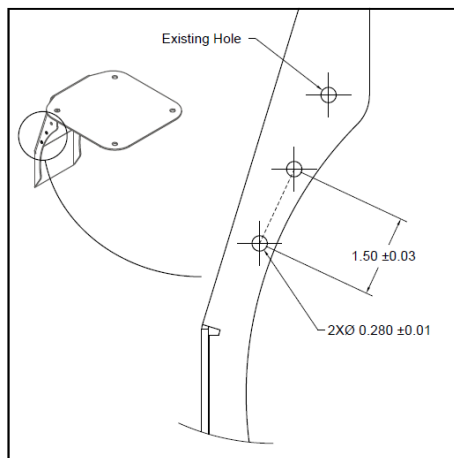
Fig.3

When turning, the routing of the wheel drive harness may allow too much flexing of the wires thereby increasing fatigue and possibly leading to premature failure of the harness, or the harness may be rubbing on the splash shield.

Replace the existing harness and install the new Traction Harness Kit (PN 56384713). This kit contains detailed instructions showing the new routing. Two new holes will need to be drilled in the splash guard (Fig.3), template included in the instructions. Serial number found on nameplate shown below Fig.1
