# TECHNICAL SERVICE BULLETIN

**Number:** TSB-FC-2016-010

**Symptom:** Charger error C4.

SC500

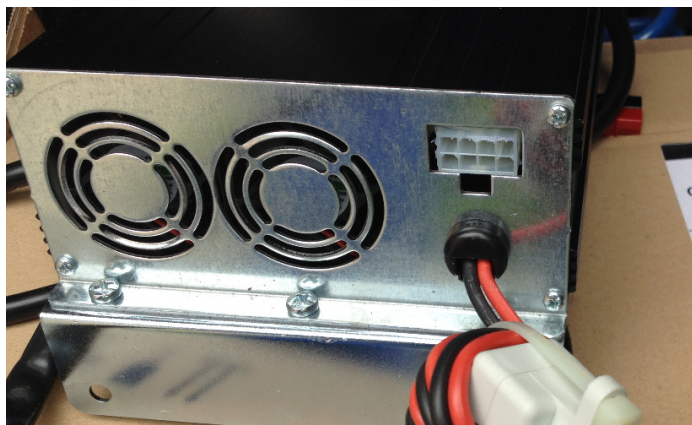
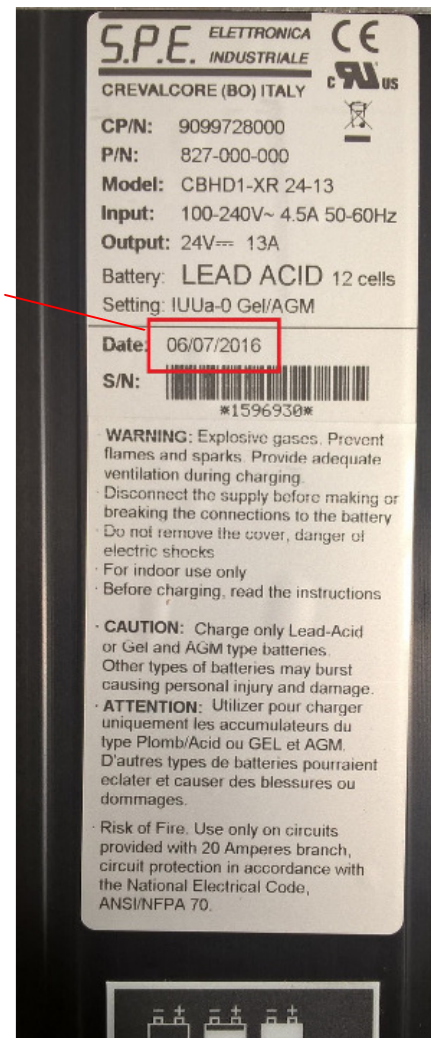
## COMPONENT LOCATIONS / PICTURES:

Charging process stop due to one cooling fan not working, so the machine show exceeded temperature error - C4.

The supplier introduced a new fan model using new magnetic levitation technology, but despite testing and higher tech data the new fan seems less reliable or intermittent functioning.

OK

Replaced the maglev fan with a traditional ball bearing fan, model already used in almost all other chargers. Onboard charger with new fan implemented starting June 2016
