TECHNICAL SERVICE BULLETIN

TSB-001-2016-11

Subject: AS710R threading hole for pedal wire improvement

Date: Oct/18/2016

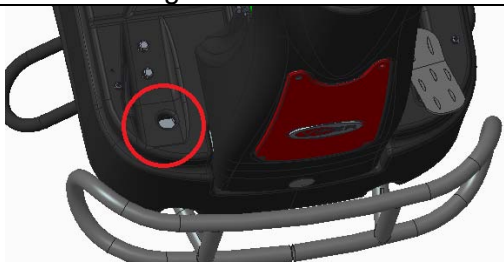
The threading hole is too small.

When replacing the pedal, the connector of the pedal wire cannot pass through the threading hole.

Design issue. The size of the connector is big, but the threading hole is too small. It needs a tool for taking the pins out of the connector, it is too complicated.

1. For new machines: We have changed the threading hole on the tank, made it bigger, now the connector of the pedal wire can pass through the threading hole directly.
