TECHNICAL SERVICE BULLETIN

TSB-001-2016-008

Subject: handle adjusting gear improvement **Date:** Oct/18/2016

SITUATION INVOLVED MACHINES: AS380B, AS380C

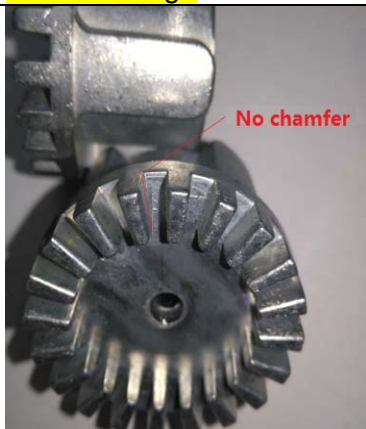
Dir-casting gears for handle adjustment were breaking

Small teeth were broken and removed.

Design issue. There are no chamfers on the lower edges of the gear teeth.

To make the teeth stronger, we have added chamfers to every lower edge of the gear teeth.
