# Nilfisk

## TECHNICAL SERVICE BULLETIN

**Number:** TSB-FC-2018-013  
**Symptom:** Oil leak from transaxle  
**Date:** 30/11/2018  
**Urgency:** Low  
**Author:** Alberto Rastelli

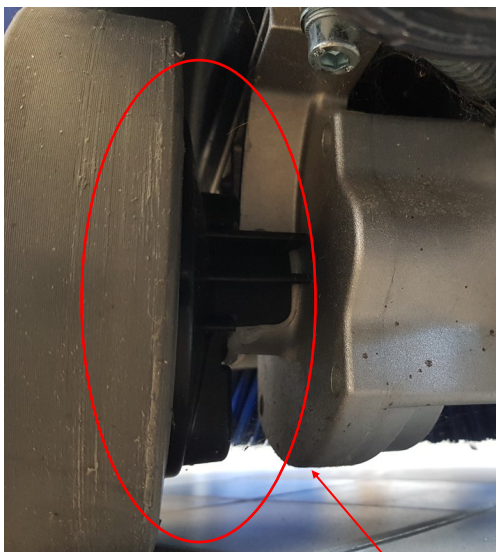
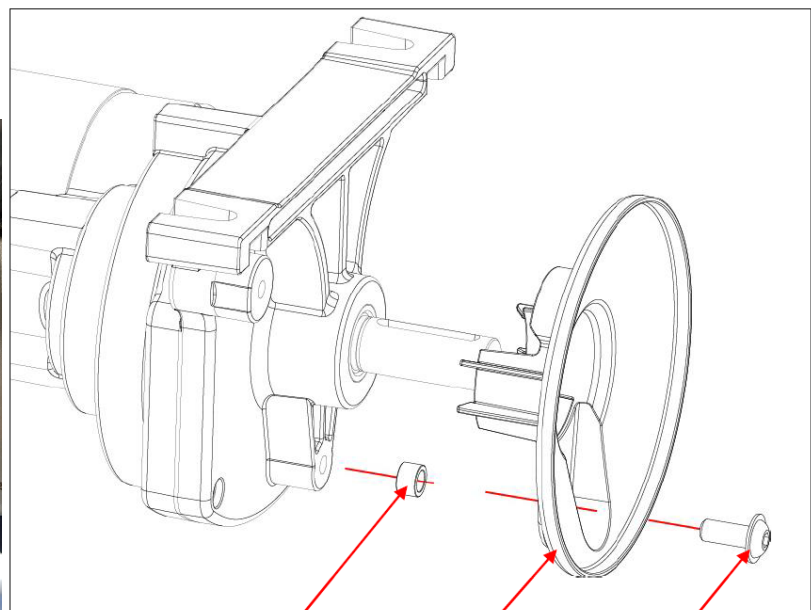
New shield KIT 9100002594

**ISSUE:** Locked drive wheel and/ or Oil leaking at the transaxle.

After long time usage the hair, and long fibers can roll up around the shaft and lock the drive wheel.

Add a cover for the wheel in order to avoid that the hair or the dirty push between the shaft and the bearing ball.

It is possible to improve the field SC500 scrubber reliability by adding the new shield KIT.

9100002594 - CARTER WHEEL PLASTIC KIT
