## Photos of Planar LIDAR for Damage Assessment

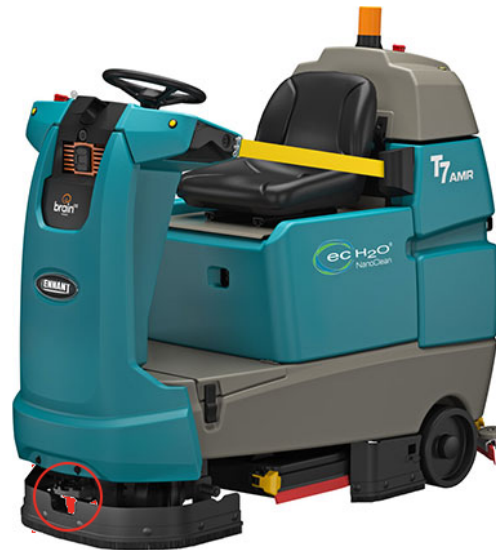
The planar LIDAR is at the bottom front of the Auto-C scrubber, below the plastic fascia and above a steel bumper as shown by the red arrow.

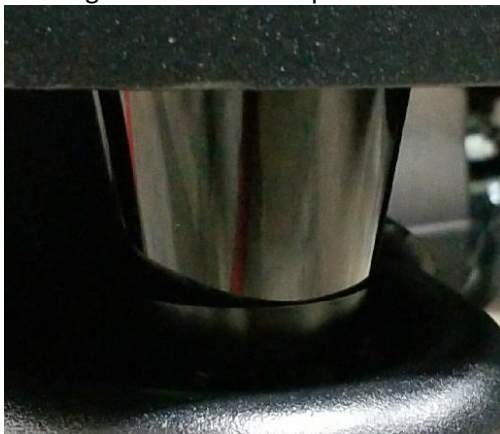
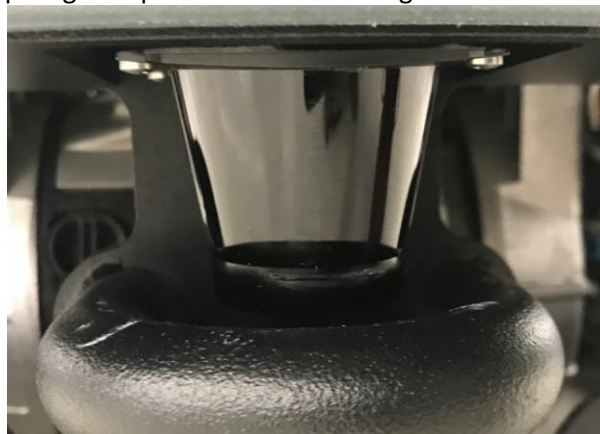
The following show the kind of photos which help diagnose potential LIDAR damage.
