# Troubleshooting/Replacing the Traction Encoder

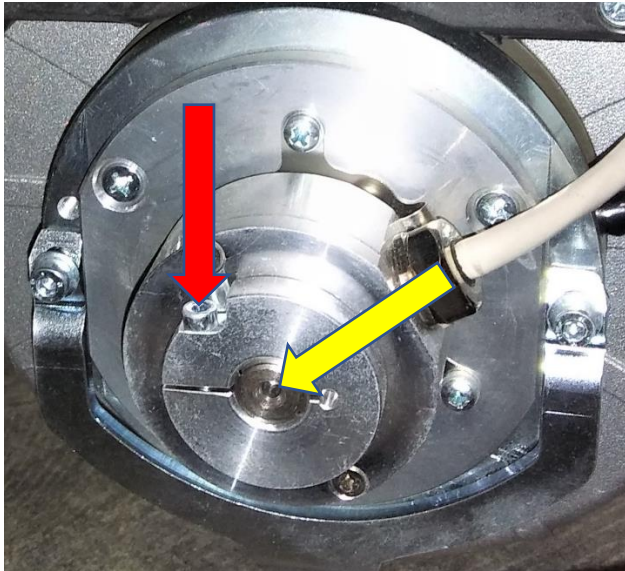
1. The indicated hex screw should be tight, which should enable the encoder to bite the center axel. As the unit is driven, both the encoder and axel should spin. When it spins, ticks are sent and counted by the robot.

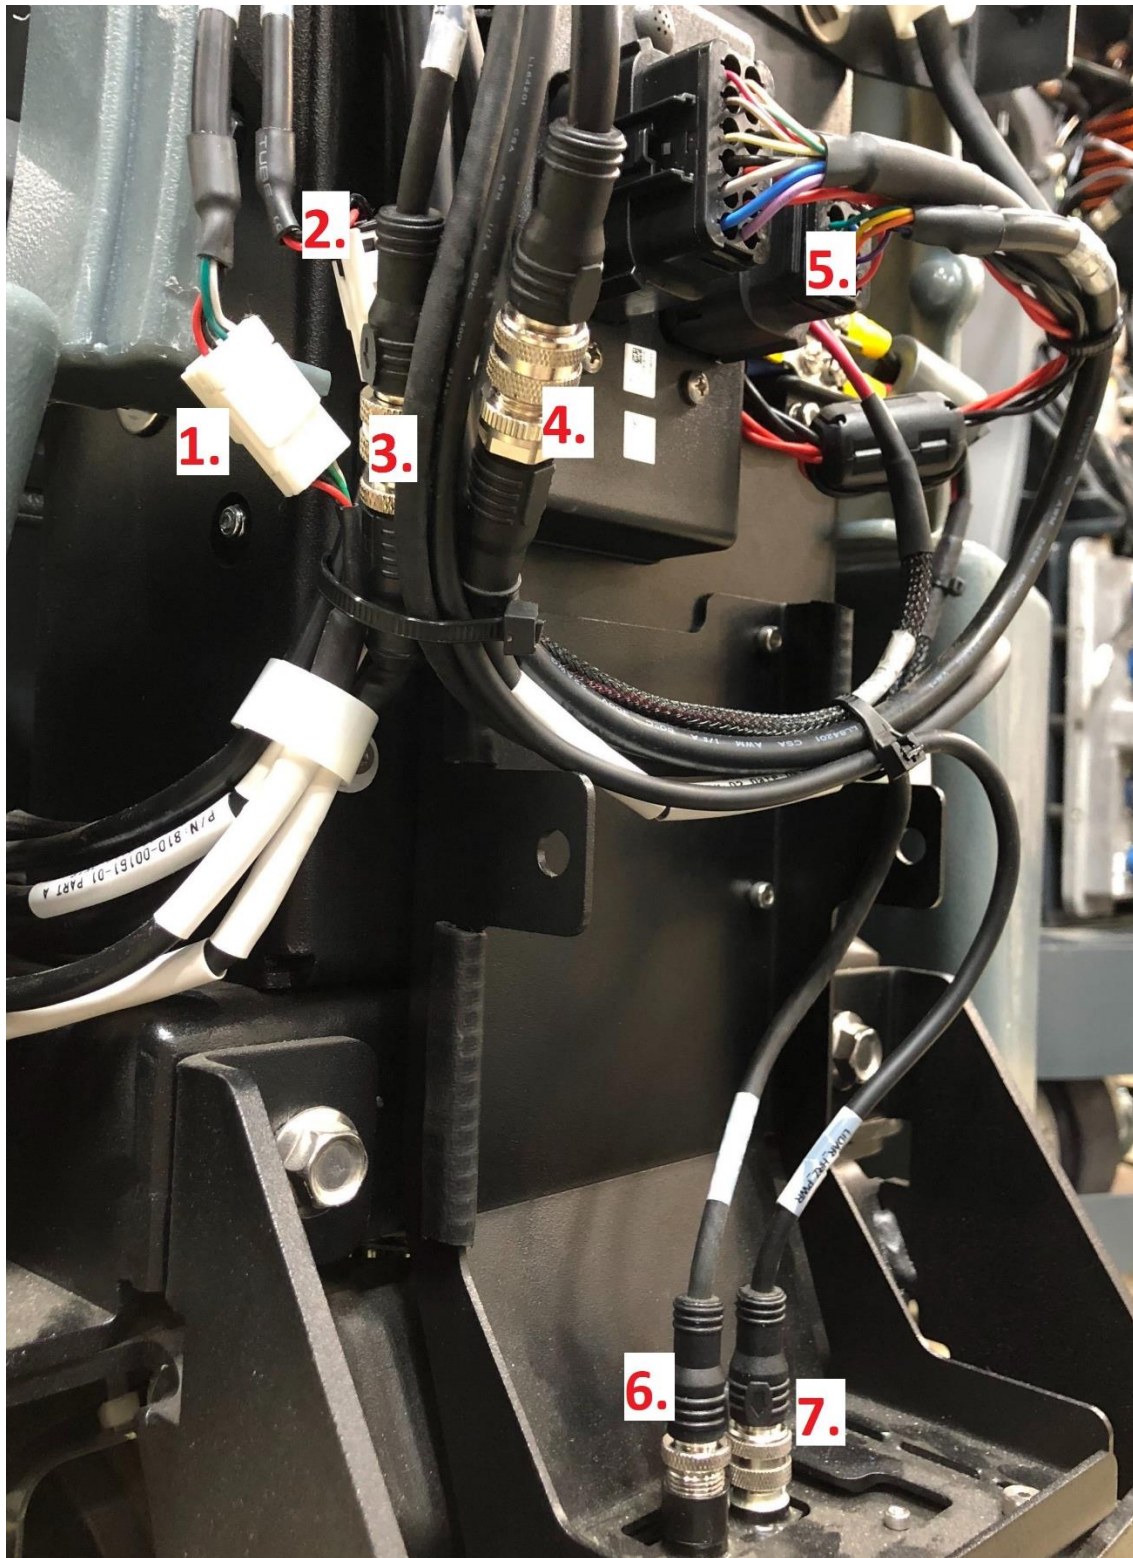
2. The Downtrunk is a cable bundle that connects various sensors, encoders and indicators to a common plug which couples to the Brain Control Module (BCM). The cable from the BCM isn't long enough to connect to the encoder, so an extension is utilized. Here we will bypass the extension and connect the replacement encoder directly to the Downtrunk cable.

1. START\_PAUSE
2. ESTOP
3. SP\_ETH (SSH Port)
4. **ENC\_TRACT1**
5. STEERING
6. LIDAR\_HRZ\_ETH
7. LIDAR\_HRZ\_PWR
8. ENC\_ABS (Steering Encoder)

Once plugged in, spin the inner part of the encoder by hand and look for a traction response on the Steering Angle diagnostic screen. If a response is not seen with the new encoder, then the issue may be in the Downtrunk, the BCM or the software. Replacing the Downtrunk is the next step, which is outlined in a separate procedure.

If a response is seen, then the Downtrunk is good and the issue is likely with the original encoder itself or with the extension cable.

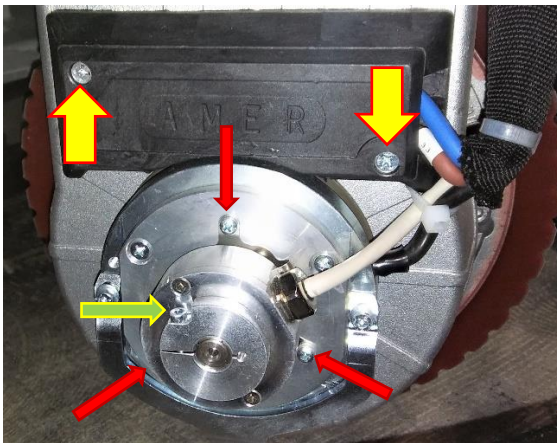
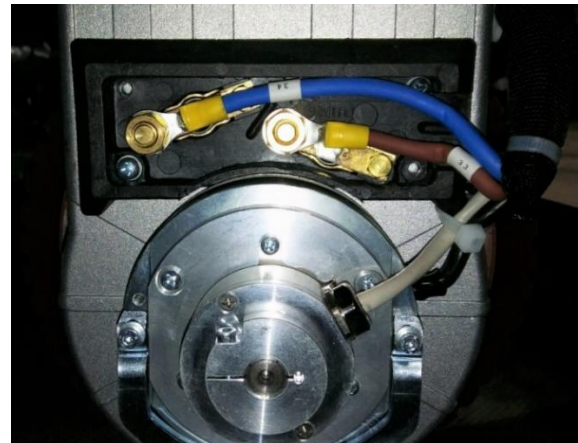
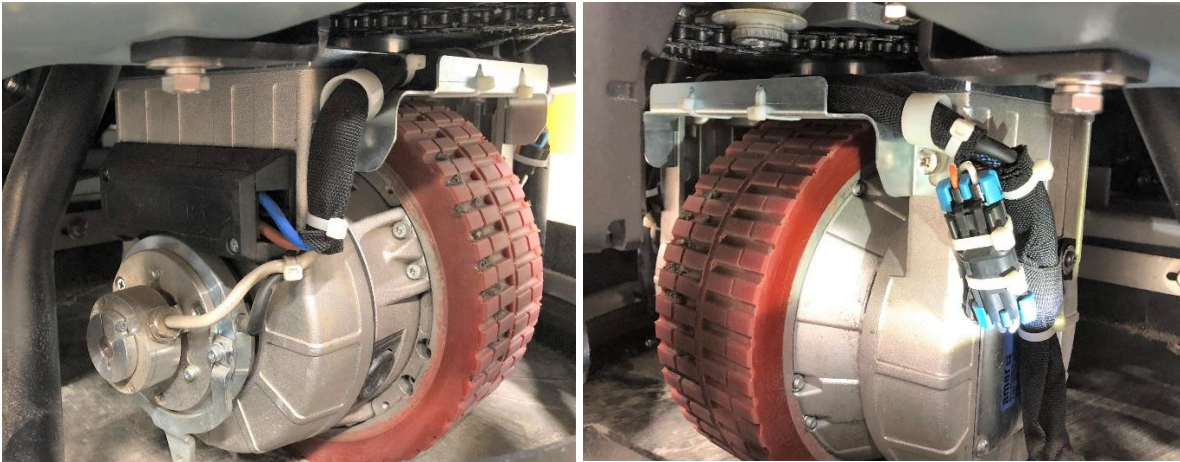
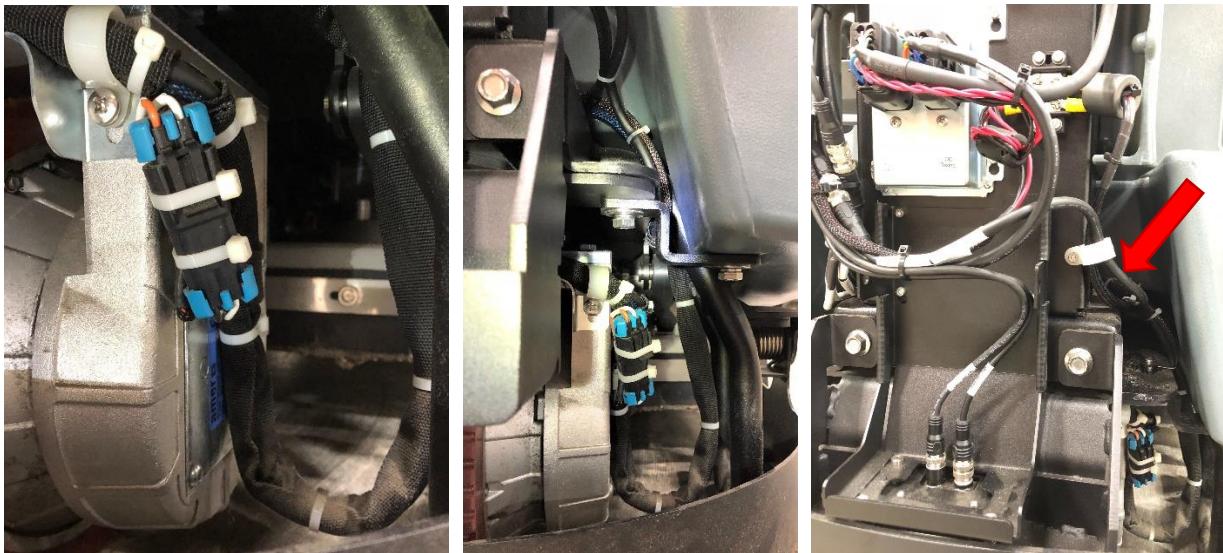
Remove the black shield which covers the drive power connection. Loosen the nuts and free the cables. **Note: The unit will be powered on at this time, so it is important, with the cables exposed, not to trigger the seat sensor and push the accelerator pedal.**

Loosen the hex screw which locks to the center axel, then remove the three Phillips screws that secure the encoder.

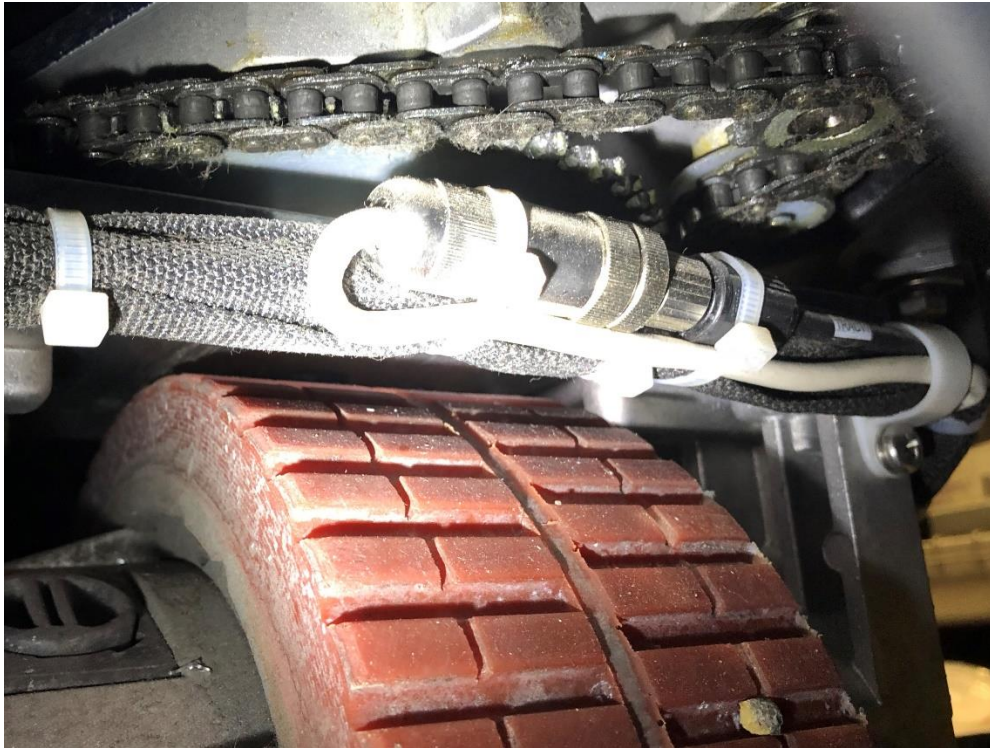
It will be necessary now to cut zip ties and remove the screws that hold the plastic routing loops. The goal is to pull the bundle away from the unit to allow access and pull back the weaved mesh to expose the coupling beneath. It is tedious and can be difficult, but it can be done. The coupling looks very similar to this within the sheath.

Decouple the encoder from the extension cable. Plug the new encoder into the extension cable, spin the inner part of the encoder by hand and look for a traction response on the Steering Angle diagnostic screen.

If the traction value increase/decrease, then the faulty part was likely the encoder. If the traction value still doesn't increase, the issue may be in the extension cable.

Plug the original encoder directly into the Downtrunk, spin the inner part of the encoder by hand and look for a traction response on the Steering Angle diagnostic screen. If the traction value increases, the faulty part is likely the cable. If the value STILL doesn't increase, both encoders may be bad. It is also possible that the BCM or the software may be the cause.
