Frosting of a Fuel Regulator on a Propane Buffer

Purpose: To show the difference between a normal looking fuel regulator, one that has been frosted due to a propane tank being too full, and the steps to rectify this problem.

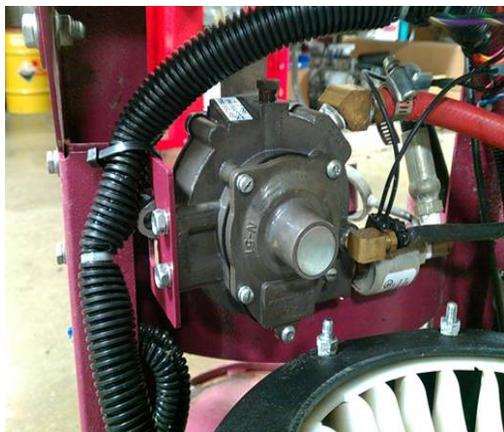
This picture is of a normal fuel regulator on a propane buffer.

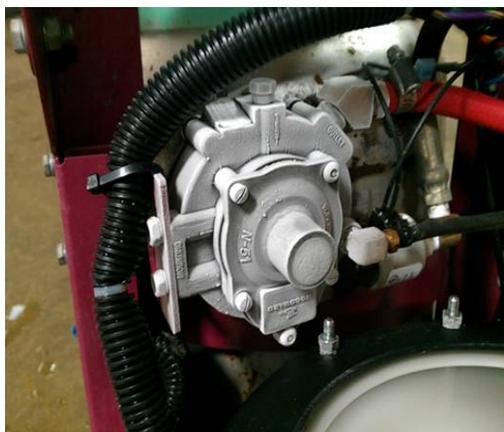
The frosting of the fuel regulator is caused by the propane tank being filled too full by a propane filling station. The liquid propane is entering and passing through the regulator and is causing the frost to develop on the outside. If frost on the outside of the regulator happens, the machine needs to be turned off immediately and the venting procedure performed below. The liquid propane can and will damage the internal parts of the regulator and cause permanent damage to the diaphragm material causing it to rupture. This will cause extremely high CO emissions, leading to the replacement of the regulator.
