## Technical Service Bulletin

**Subject:** False error code 07 vacuum overload shut down

## VACUUM MOTOR CIRCUIT REPLACEMENT HARNESS INSTALLATION

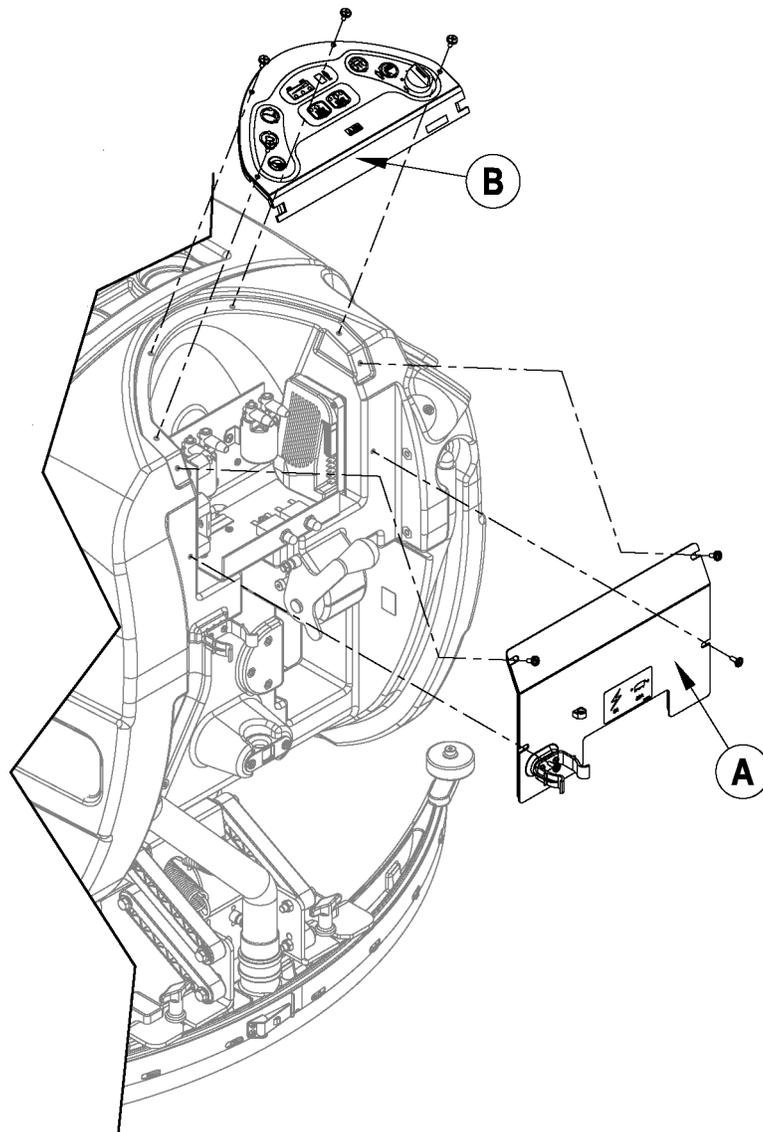
**FIGURE 1**

1. Disconnect the batteries.
2. **See Figure 1.** Remove the electrical panel cover (A) and the control panel assembly (B) to gain access to the electrical compartment.

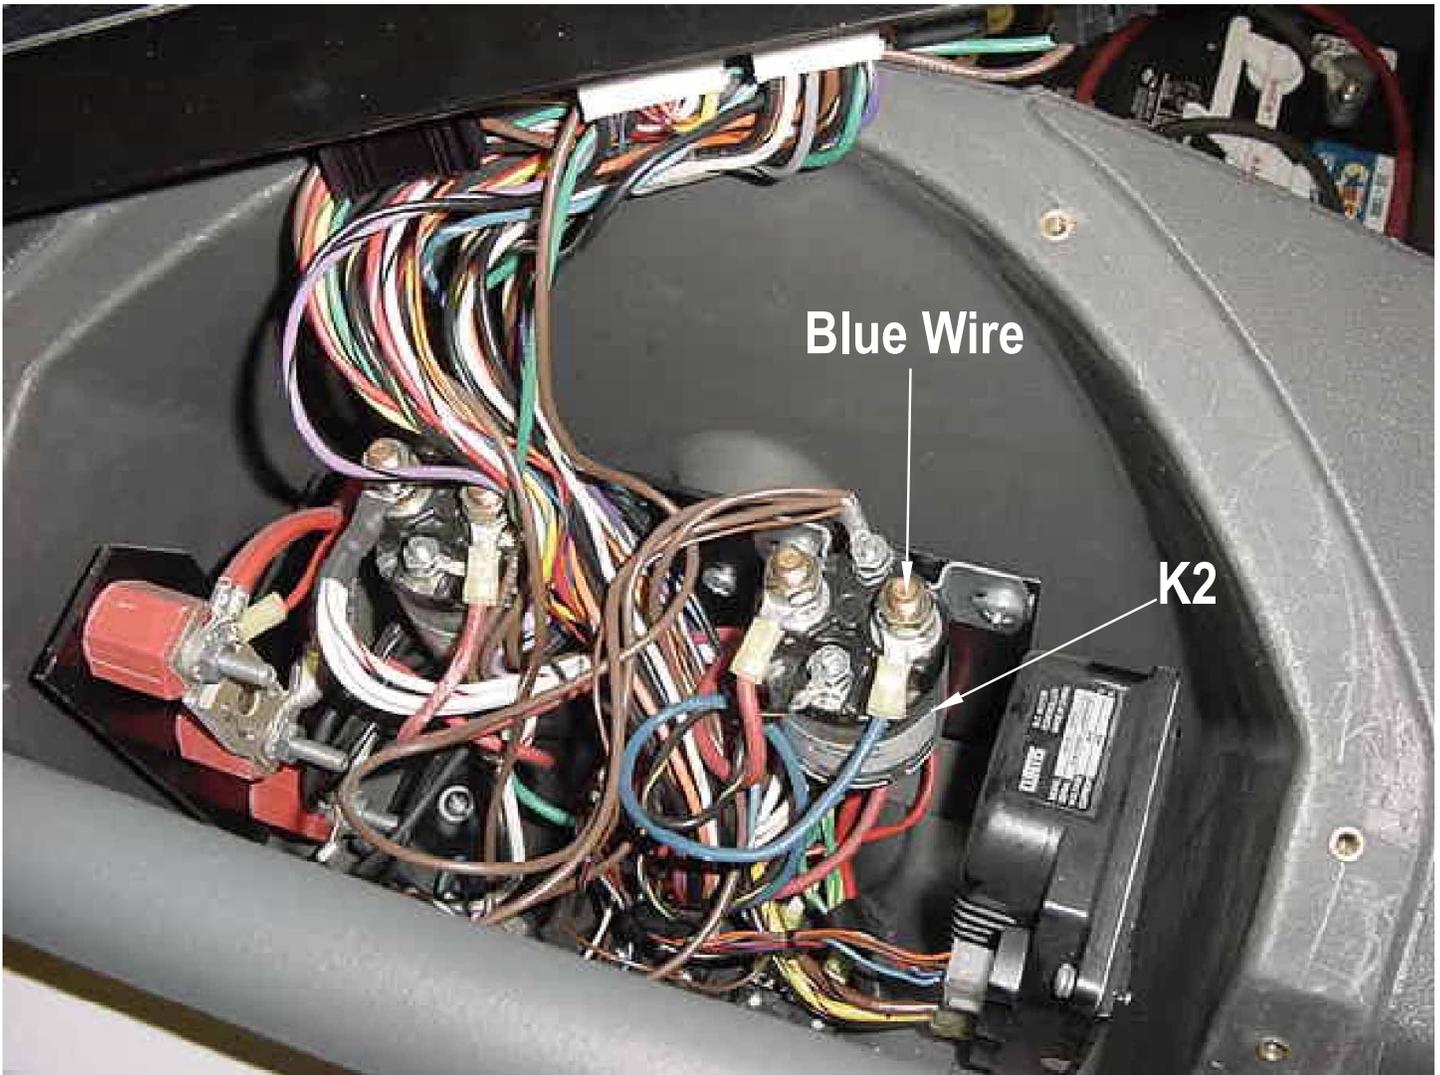
**FIGURE 2**

3. See Figure 2. Disconnect the blue wire from the vacuum motor contactor (K2) then cut it off where it goes into the main harness. This wire will no longer be used.

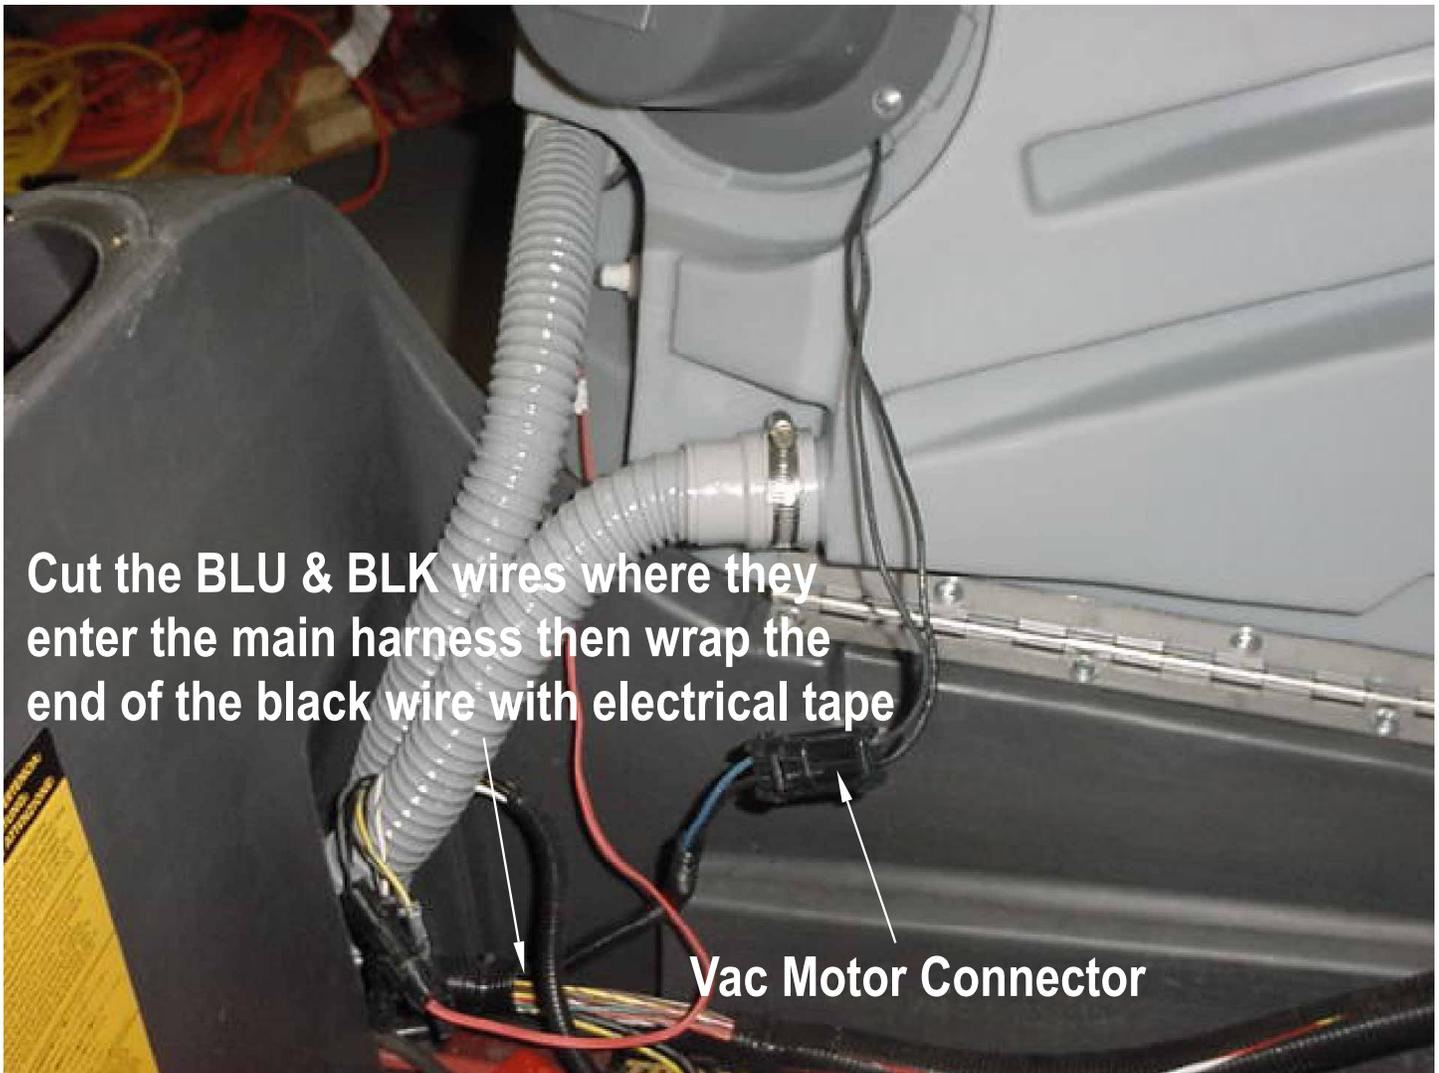
**FIGURE 3**

4. **See Figure 3.** Disconnect the connector with the blue and black wires that plugs into the vacuum motor leads.
5. Cut the cable tie that secures these two wires to the vacuum hose near the recovery tank. Then cut both wires (Blk & Blu) off where they enter into the main harness. Next wrap the end of the black wire with electrical tape so there are no strands of wire exposed. The blue wire does not need to be taped because it is disconnected at the other end.

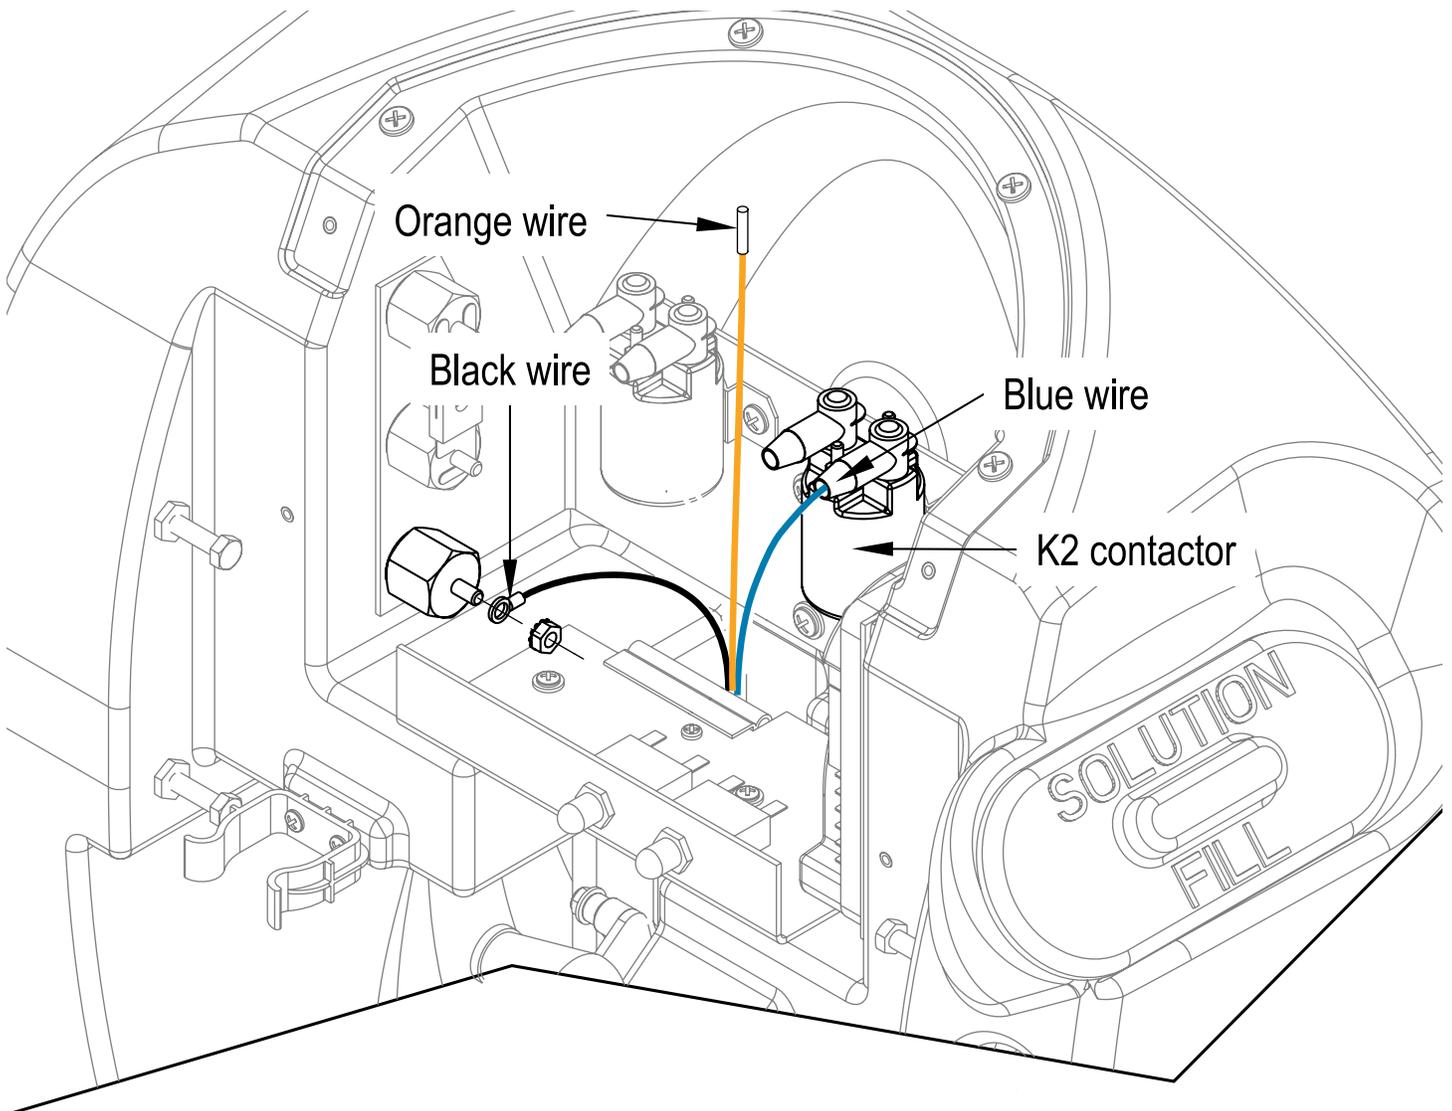
**FIGURE 4**

6. Install the replacement harness by plugging it into the vac motor connector, then routing it along side the main harness from the vacuum motor connector into the electrical compartment (route up and behind the circuit breaker panel / see figure 4). Using cable ties (not included), secure the replacement harness to the main harness and to the vacuum hose where the old blue and black wires were previously secured.
7. **See Figure 4.** Connect the blue wire from the replacement harness to the vacuum motor contactor (**K2**) terminal that the old blue wire was previously connected to (figure 2).
8. Connect the black wire from the replacement harness to the bottom (BAT-) junction terminal (stand-off) in the electrical compartment along with the other black wires that are there.

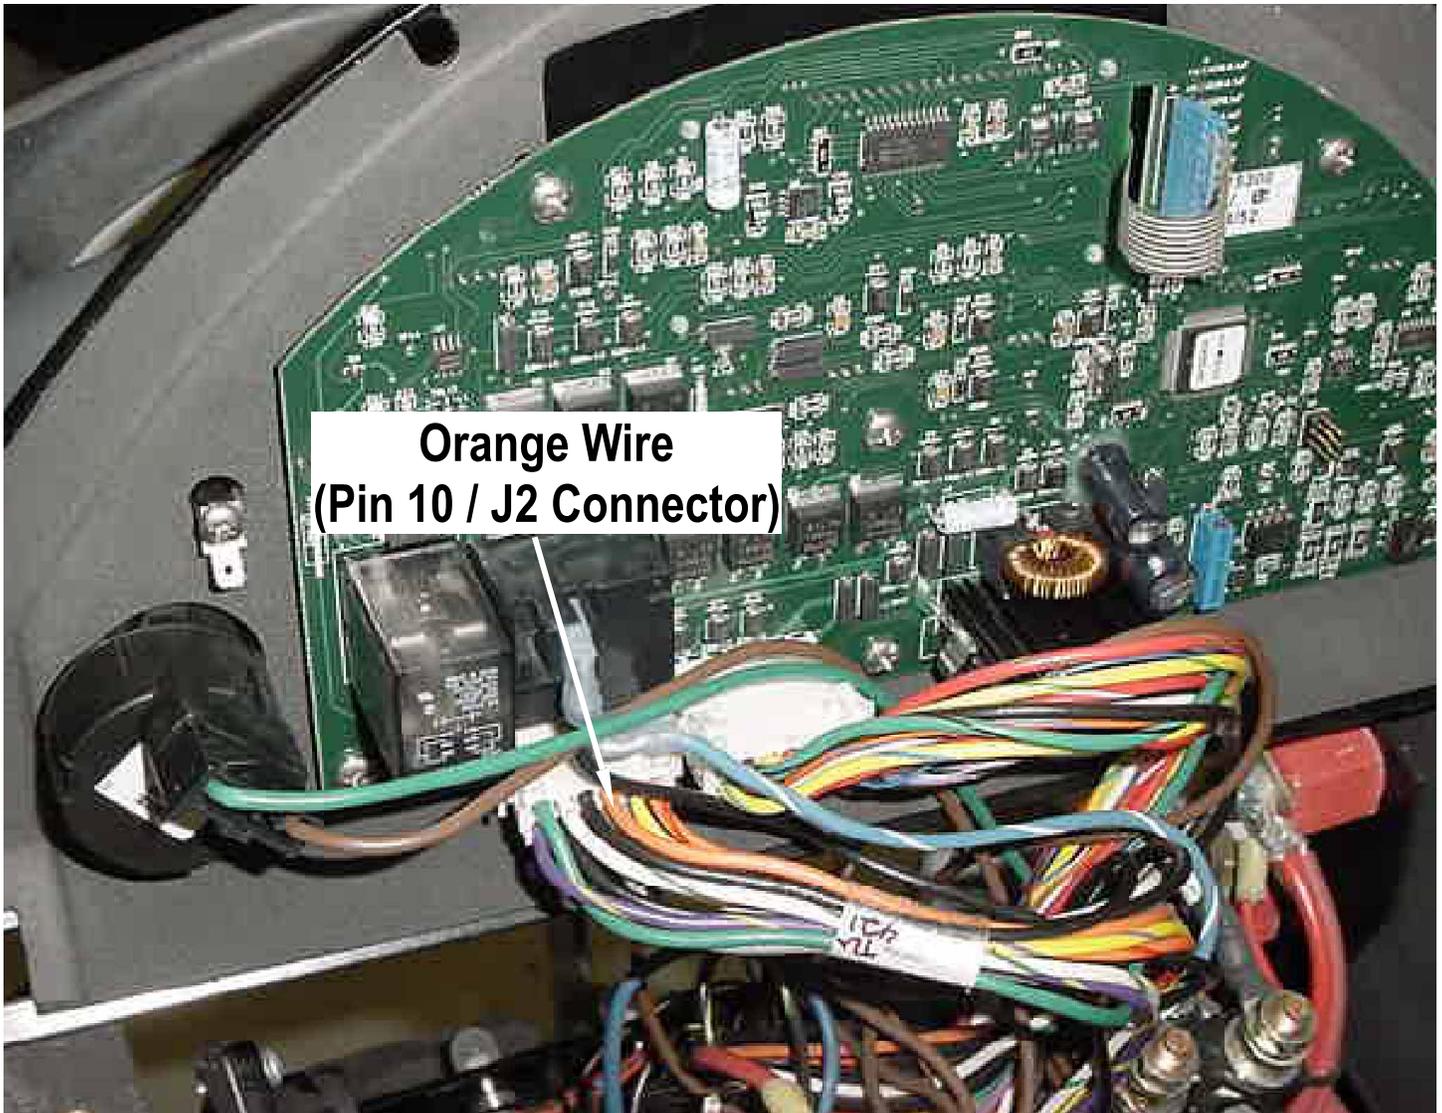
**FIGURE 5**

9. **See Figure 5.** Find the orange wire that goes to Pin 10 of the white 12 way (J2) connector that plugs into the control panel assembly (A1). Cut this wire a few inches away from the connector and strip 1/4" of insulation from the end of the wire that goes into the connector. Using the butt splice that is on the orange wire from the replacement harness, crimp it onto the orange wire that goes into the connector.
10. Replace all the panels and reconnect the batteries. Test the machines drive and scrub functions.
