## Technical Service Bulletin

**Subject:** Solution Valve Leakage (56265037, 56265114)

**Models Affected:** Advance Aquaclean: 56265300, 56265000, 56265001, 56265003, 56265008 / Kent Klenzor: 56265004, 56265005  
Nilfisk AX 310/410: 56265302, 56265303, 56265002, 56265007 / Euroclean Xtrac: 56265301

**Issue:** Solution leaking from jets when machine is off

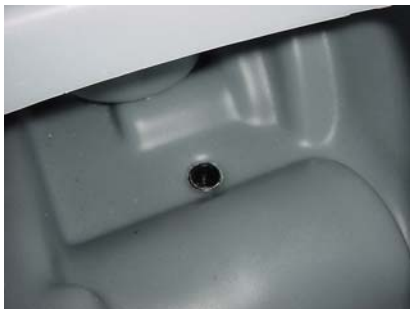
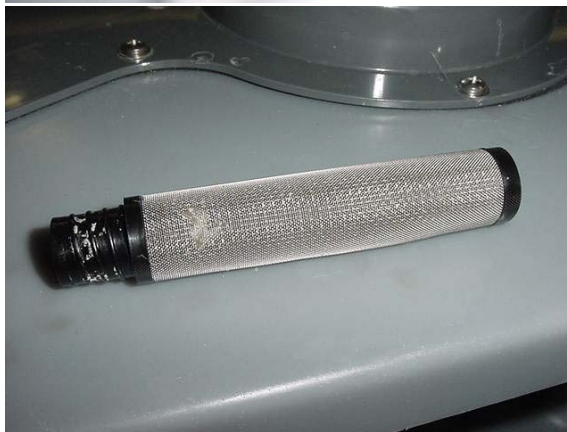
Barb is pressed into fitting in solution tank

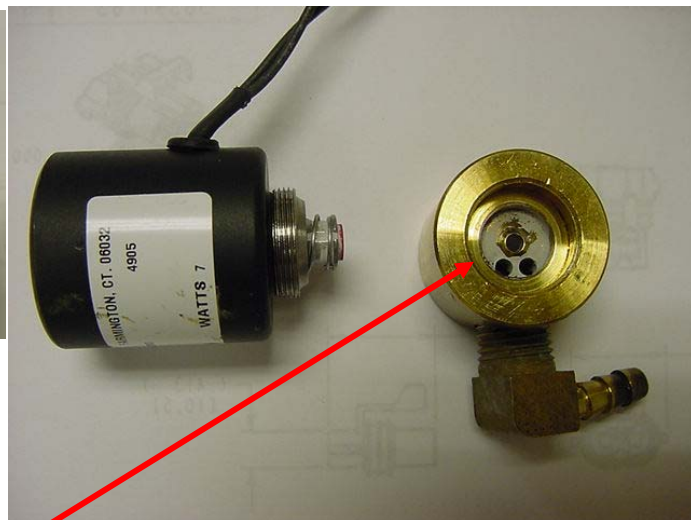
Solenoid plunger seats against valve body to block flow from inlet port.

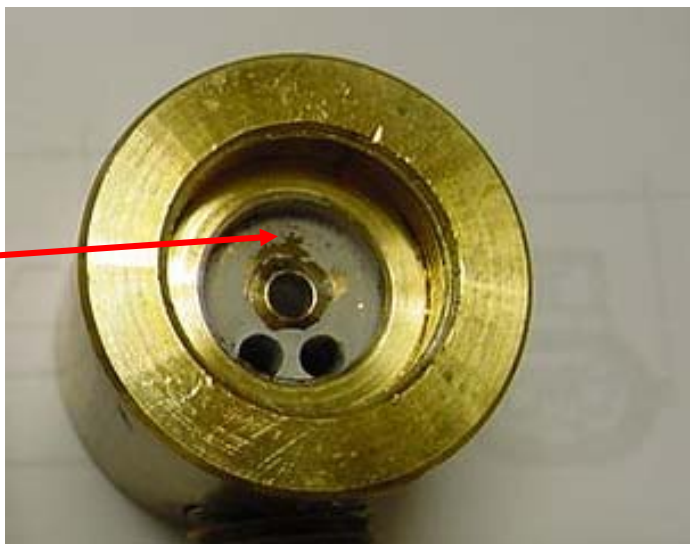
Scale build-up on this surface or plunger will prevent proper sealing

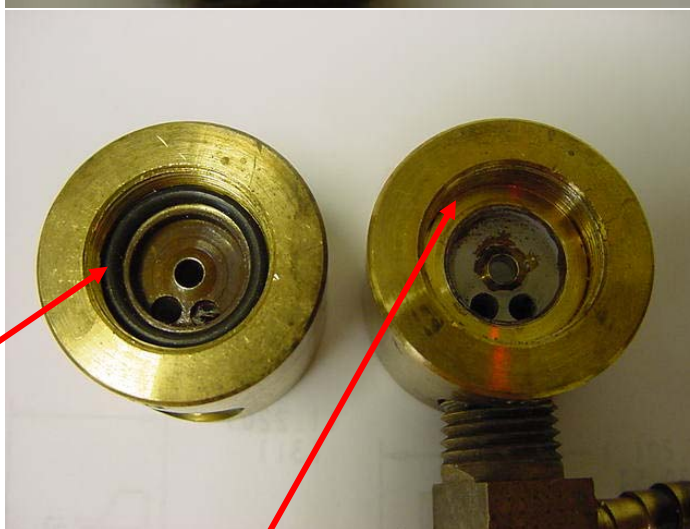
Valve body should have O-ring as shown to prevent leakage between valve body and solenoid.

Missing O-ring
