Machine	TASKI swingo 350B 455B 755B Eco
Subassembly	Electronics

Layout change of the electronics board

GTS Newsletter

2020/13E

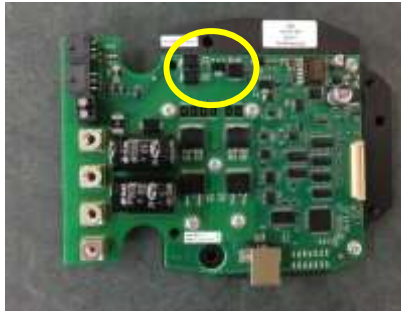
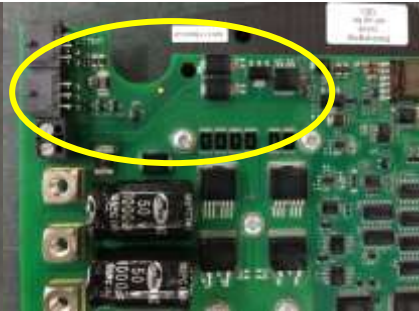
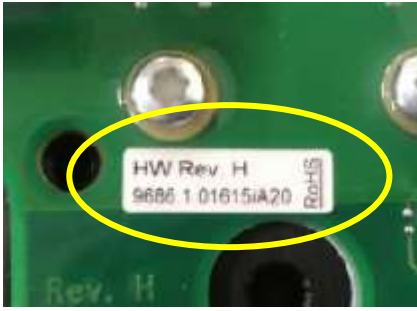
We have received some returned electronics from the field, which have shown damages in the pump control.

Due to an overload of an electronic component on the electronic board (so-called FET), the pump was then supplied with a continuous voltage instead of with an intermittent PWM signal. This led to a chain reaction in which the pump and then the electronics failed.

Overview with FET's	Pump control	Revision marking H

The electronics are now equipped with generously dimensioned FETs that prevent this behavior. The new electronics are marked on the electronics print with hardware revision H.
