Technical Service Bulletin

MODEL(S) T300/T300e Models

SUBJECT: Scrub head lift pedal difficult to disengage from raised position.

PURPOSE: To improve scrub head lift pedal function, order Pedal Latch Upgrade Kit p/n 9014788.

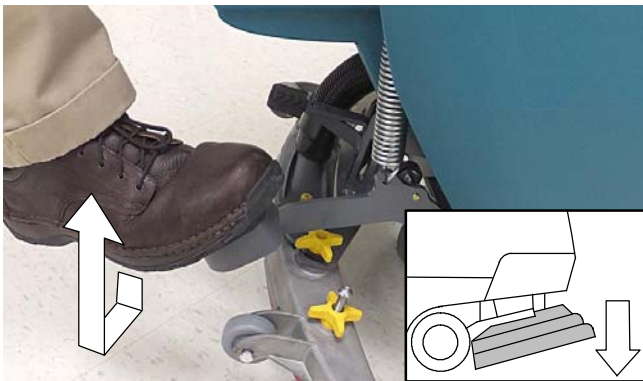
Scrub head lift pedal function.

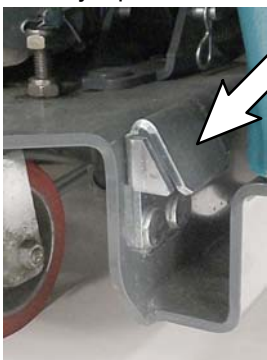
Old style pedal latch

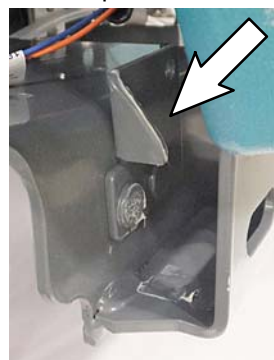
New kit pedal latch
