# Technical Service Bulletin

**MODEL(S) AFFECTED:** **T600/T600e/T600 EE Walk-Behind Scrubbers**

**SUBJECT:** Potential damage to plastic solution tank fitting. Reports claim when delivering or storing machines behind one another the scrub head of the rear machine may hit the fitting and damage it. A raised squeegee assembly may also damage the fitting if the squeegee assembly pivots into it with excessive force.

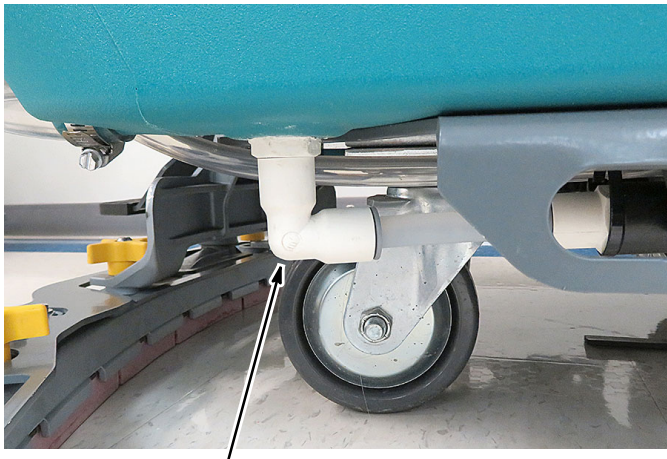
Plastic solution tank fitting

**PURPOSE:** To repair or prevent fitting damage, replace plastic fitting with brass fitting (p/n 1243587).

**Installation Note:** Before installing brass fitting, drain solution tank and use a threaded pipe sealant on fitting.

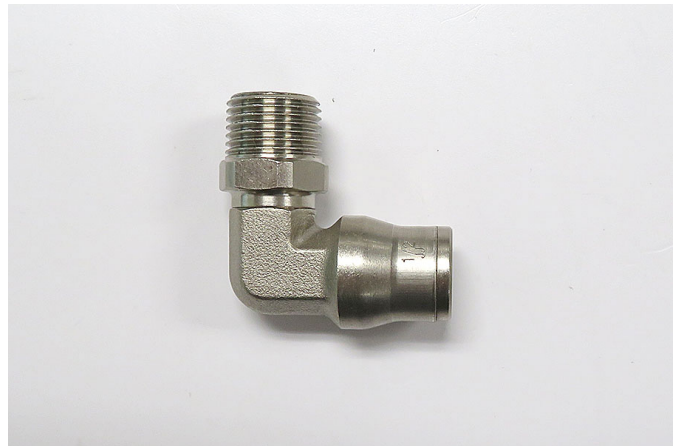
Brass fitting (p/n 1243587)
