# Technical Service Bulletin

**MODEL(S) AFFECTED:** T600/T600e/T600EE Walk-behind Scrubbers

**SUBJECT:** Squeegee lift mount durability upgrade. Normal wear and tear on the squeegee mount pivot pin and mounting holes may slowly cause the blade pitch to change and eventually affect squeegee performance.

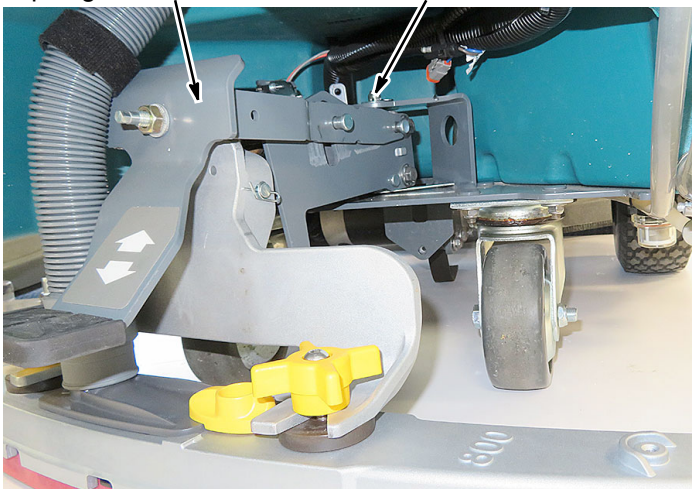
Squeegee Lift Mount

Pivot Pin

Check pivot pin and mounting holes in frame for wear (i.e. deep grooves in pin and elongated holes). Install the upgrade kit if unable to maintain proper blade roll-out using the blade pitch adjustment as described below. If the adjustment stem is near full adjustment (less than 1 stem rotation remaining) with proper blade roll-out, install kit.

**PURPOSE:** For customers that have experienced the above condition, install the Squeegee Mount Upgrade Kit p/n 9020916. The upgrade kit is designed with flange bushings to protect pin and frame from wear.

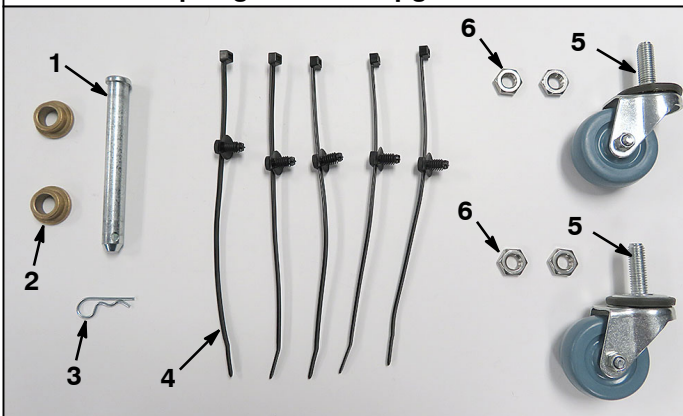
## 9020916 - Squeegee Mount Upgrade Kit Contents

| Ref | Part No. | Description | Qty. |
|---|---|---|---|
| 1 | 1233450 | PIN, CLEVIS, 0.50D X 4.30L | 1 |
| 2 | 1251209 | BUSHING, FLNG, 0.50B 0.75D 0.38L | 2 |
| 3 | 86866 | PIN, COTTER, HAIR, 0.38D .072 WIR | 1 |
| 4 | 1210807 | WIRE, TIE [W/.25" FIR TREE CLIP] | 5 |
| 5 | 1006343 | CASTER, SWIVEL, 50MMD, M10 X 30 | 2 |
| 6 | 32716 | NUT, HEX, JAM, M10 X 1.5, SS | 4 |

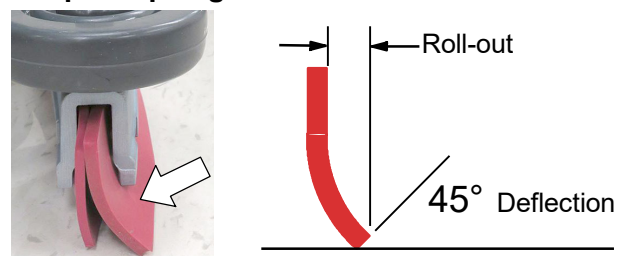
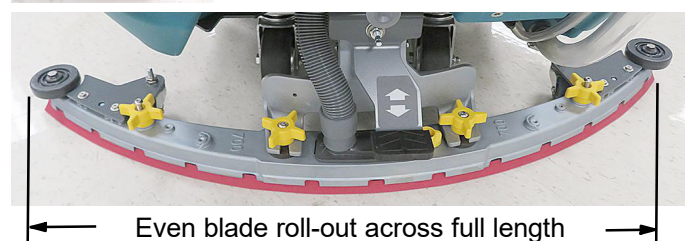
## Proper Squeegee Blade Roll-out

**Blade Pitch Adjustment:** Turn the pitch adjustment stem counter-clockwise to raise blade tips or clockwise to lower the blade tips. 7mm & 17mm wrenches required.
