# TECHNICAL SERVICE BULLETIN

**Number:** TSB-FC-2017-035

**Symptom:** Li-ion battery does not work.

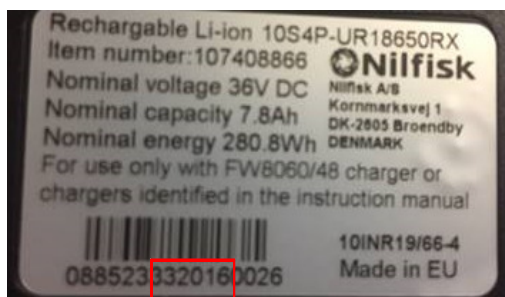
*The mfg date is the last numbers in the string under the bar code.*

*The sample label show week33 2016*

Battery pack date code starting in 2016ww43 production.

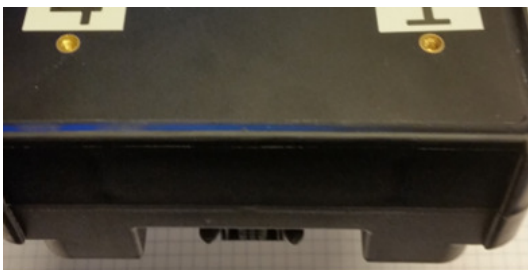
*Opening the battery pack is strictly forbidden, Nilfisk technicians are not supposed to open the battery primarily for safety reasons.*

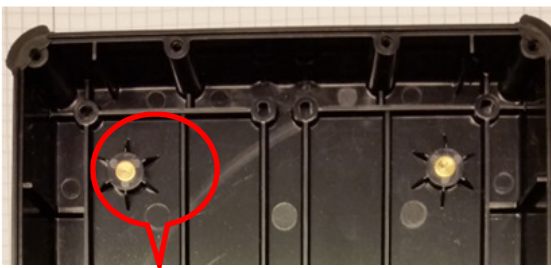
The SC250 when used dry on a vinyl floor generates an excess of 20kV of static electricity. The battery pack PCB was damaged by ESD thru one of the 4 metal inserts on the back of the battery.

*The battery pack ESD (electro static discharge) path is via the "open" brass inserts, jumping to the BMS (battery management system) PCB where ESD sensitive electronic components are damaged.*

The 4 metal inserts have been insulated to help to block ESD and prevent it from reaching the battery PCB.
