# GTS Newsletter

2008/06E

| <b>Machine</b> | <b>TASKI swingo XP</b> |

## Squeegee Lowering Mechanism

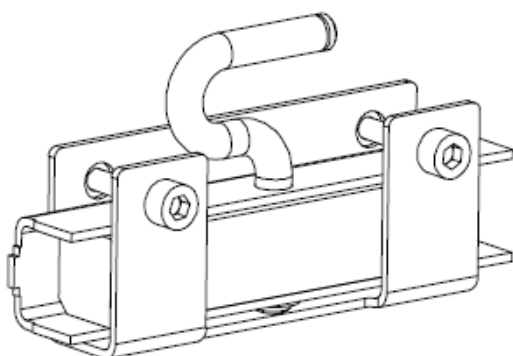
Feedbacks from the market have indicated that due to permanent moving of the bolt the squeegee lowering mechanism can extend and damage the relevant passage in the chassis. Because of this reason a set which can be fitted into the existing machines is now available.

| Description | Material Number | Status |
|---|---|---|
| Squeegee lowering mechanism modification set | 4127903 (18603-32) | available |

**The relevant strengthening of the chassis has been realised from machine no. 2410.**

When doing a regular service on a TASKI swingo XP we recommend a thoroughly visual examination of the chassis. If the first signs of damage are visible the modification set has to be mounted.
