# GTS Newsletter

2008/12E

| <b>Machine</b> | <b>TASKI swingo XP</b> |

## Motordrive/Brake

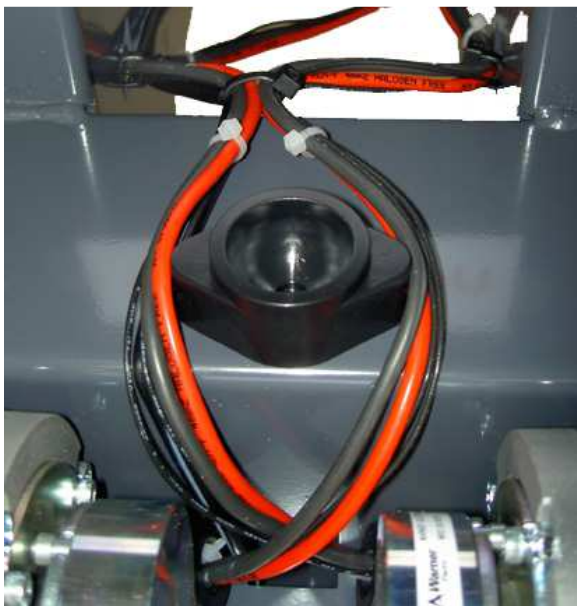
Feedbacks from the market as well as internal tests have shown us that under some circumstances the swinging arm can squash the motordrive- and the brake cables. This can lead to short circuits and results in damaging the power electronic, the motor drives and/or the brakes.

*New positioning of the cables  
(from underneath)*

The cables are now fixed with an additional cable tie above the ball joint (see picture below). The current fixations of the cables to the left and to the right are still necessary.

**Please ensure that the cables are strong tightened to the chassis.**

**Defective cables must be repaired or replaced in any case.**

On each TASKI swingo XP service-based visit the motordrive- and brake cables need to be checked on damages and if necessary to be replaced.

The motordrive- and brake cables must be positioned according to the new instruction on all TASKI swingo XP's.

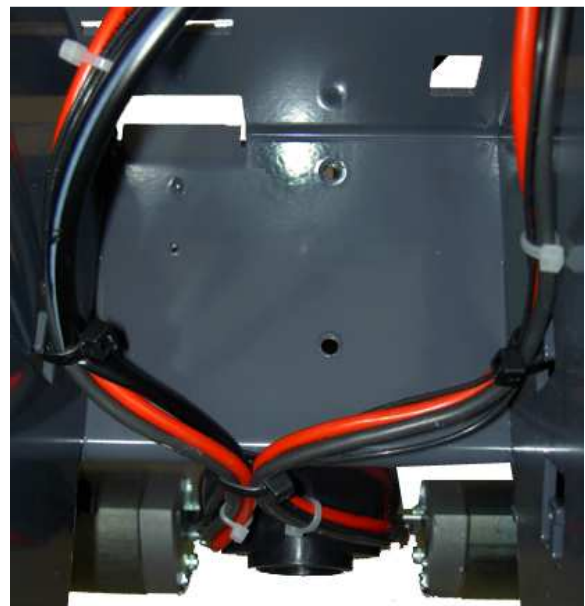
*Fixation of the cables on the chassis  
(from the side of the electronics)*
