# Technical Service Bulletin

## MODEL(S) AFFECTED: Following models equipped with Emergency Stop Button

**SUBJECT:** Functional issue with emergency stop button (Design B). When pressed, the button may not remain engaged in the lock- out position as designed. In this condition, the switch will still disable machine when pressed, but the button must be held for one to two seconds on some models such as the T5, T7 and R14.

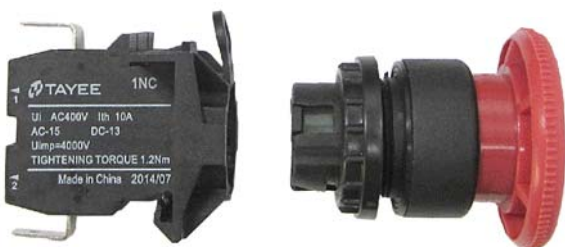
## Replace with Emergency Stop Button, p/n 1011735 (Design A)

*Note: Both emergency stop button designs share the same part number, confirm correct design before installing. Emergency stop button (Design B) has been removed from inventory.*

**PURPOSE:** For machines equipped with emergency stop button (Design B), it's recommended to replace with emergency stop button (Design A) p/n 1011735.
