# Nilfisk

## TECHNICAL SERVICE BULLETIN

Number: TSB-FC-2019-027

Symptom: Connector melt issue

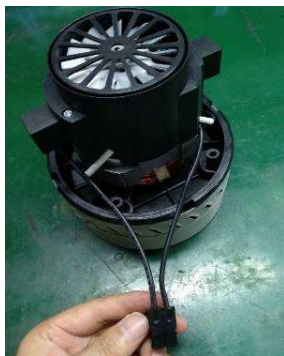
Old  
VF89309

Machine inoperable due to the brush motor and/or vacuum motor connector melted or burned out.

Over-flowed waste water penetrated into the connector and caused the connector to overheat.

Use a water-proof connector to replace the old connectors.
