**Subject:** Loose squeegee hose connection

- Adphibian (all models)
- AX651 (all models)

**Parts List Form Number(s) Affected:** 56042476

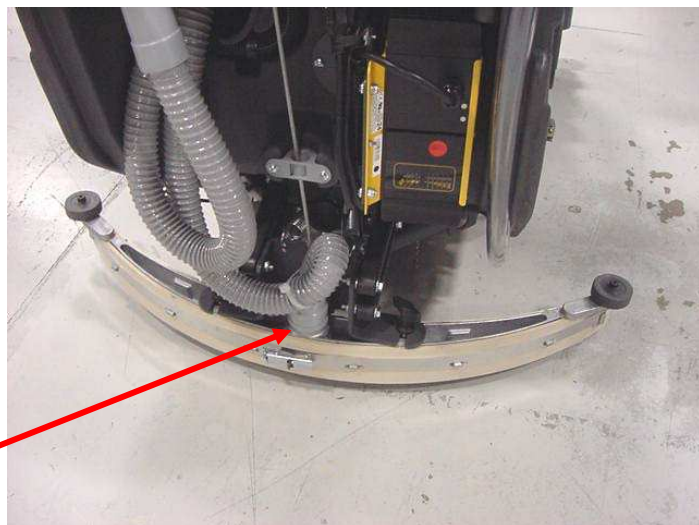
Fig 1-

**Issue:** Poor water pick-up

**Cause:** Cuff on squeegee hose does not fit tightly with tube portion of squeegee casting 56314325.

Hose cuff does not fit tightly onto neck of squeegee casting

On machines with SN's prior to those noted below contact Technical Service at 800-989-2235 or [ustechserv@nilfisk-advance.com](mailto:ustechserv@nilfisk-advance.com) to order sleeve 56317167. Install as as shown in Fig's 2-4.

Tube diameter on squeegee casting 56314325 revised to improve fit with squeegee hose cuff. Revised squeegee casting implemented effective with SN 2037724-2037725 & 2048626 on Adphibian.
