# Nilfisk

## TECHNICAL SERVICE BULLETIN

Number: TSB-CAS-2019-005

Symptom: Broken electromagnetic  
brake wire

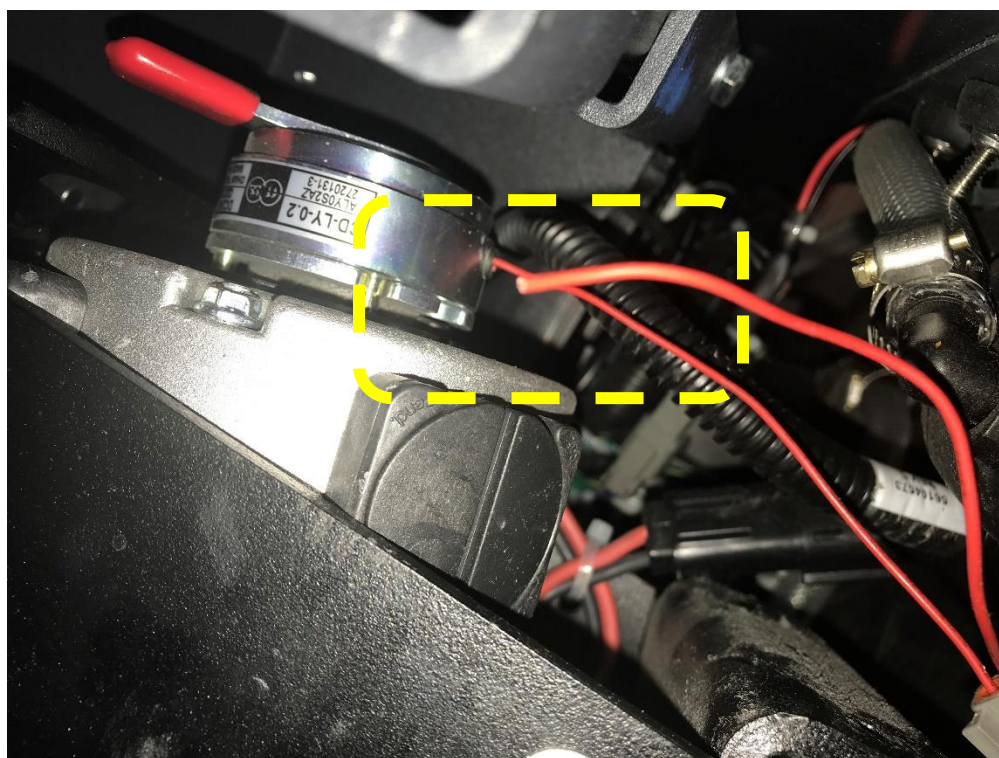
| Machine displays error code 3-036 and/or machine won't move. | |

**CAUSE:**

The electromagnetic wire pulled out (most likely) or broke (less likely).

**FIELD CORRECTIVE ACTIONS:**

1. Request 56104850 brake kit and 56122793 brake boot and follow the instructions included in the kit.

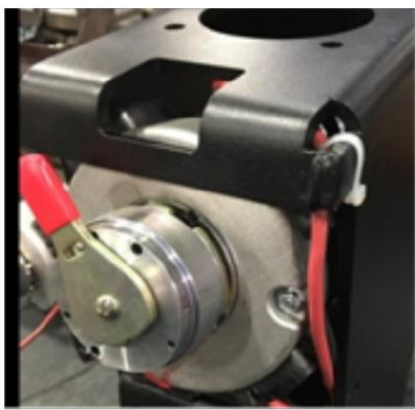
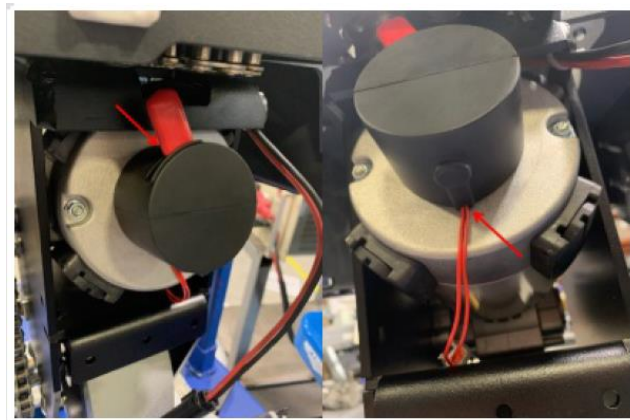
ECO A-14264 implemented in September 9<sup>th</sup> 2019 introduced a new drive wheel motor wire routing to reduce tension and possible hanging, and an electromagnetic boot to protect the wire and provide extra support in case it gets pulled.
