# Technical Service Bulletin

**MODEL(S) AFFECTED: Tennant T1, E5 and R3**

**SUBJECT:** Belt pulley screw backing out (torque bond breaking loose) due to vibration and resulting in pulley assembly damage.

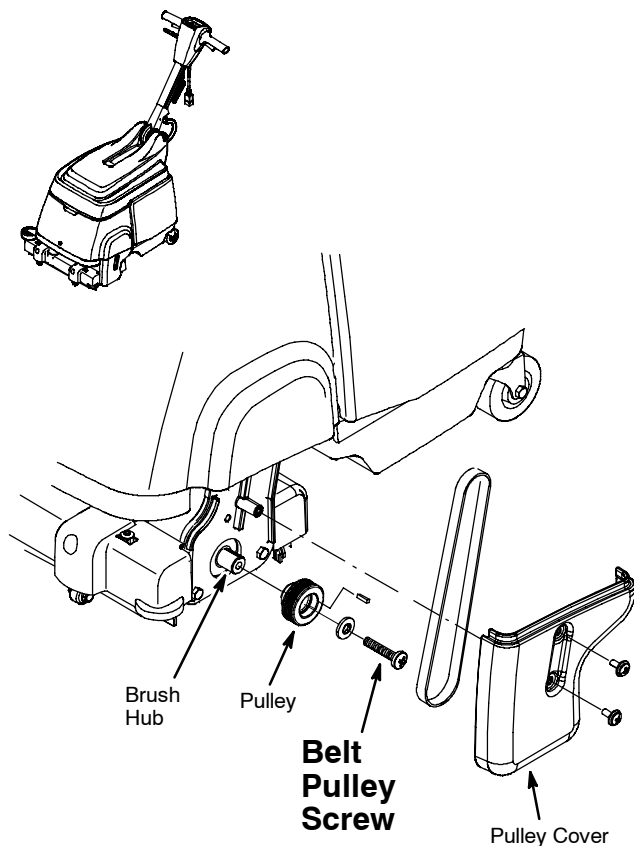
If the pulley assembly makes a grinding noise or abnormal sound, this is a good indication that the pulley screw has broken loose. The pulley cover will keep the screw from completely falling out and as a result may show signs of damage on the outside of the pulley cover where the screw presses against the cover.

**PURPOSE:** If pulley screw has broken loose and has not caused any damage to the pulley assembly, install the following service kits to prevent potential machine damage. *NOTE: Do not tighten pulley screw on machines that have not experienced this issue, you may break the torque bond.*

9006841-Pulley Service Kit (T1, E5 Models)

9006842-Pulley Service Kit (R3 Model)

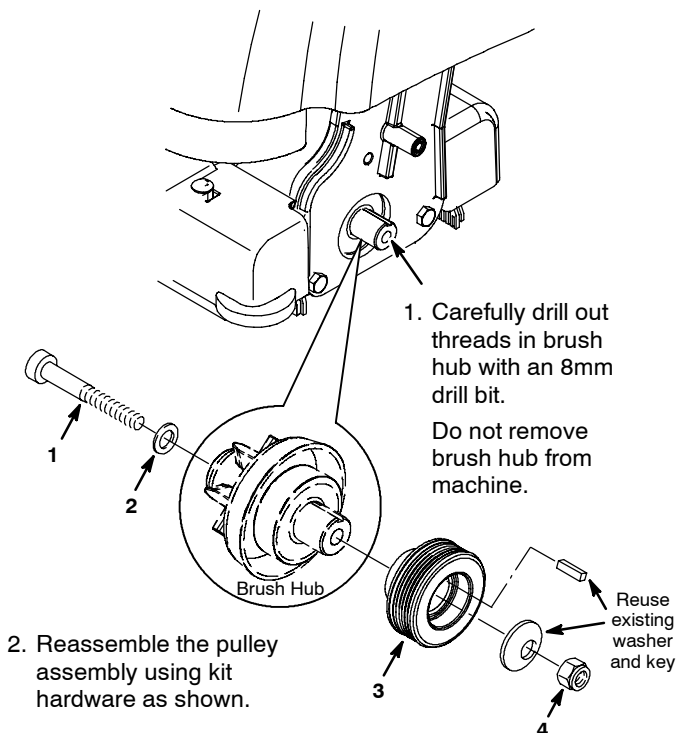
### Kit Contents

| Item No. | Part Number | Part Description | Kit 9006841 Qty | Kit 9006842 Qty |
| 1 | 1057476 | Screw, M8x1.25x55 | 1 | 2 |
| 2 | 1057482 | Washer, Flat | 1 | 2 |
| 3 | 1030614 | Pulley | 1 | 2 |
| 4 | 08713 | Nut, Hex, Lock, M8x1.25 | 1 | 2 |

## Pulley Service Kit Installation Instructions:
