**Number:** TSB-FC-2014-031 Squeegee  
Support Brackets Breaking  
UPDATED

**Symptom:** Squeegee Support Brackets  
Breaking

SC750, SC800, Focus II MidSize

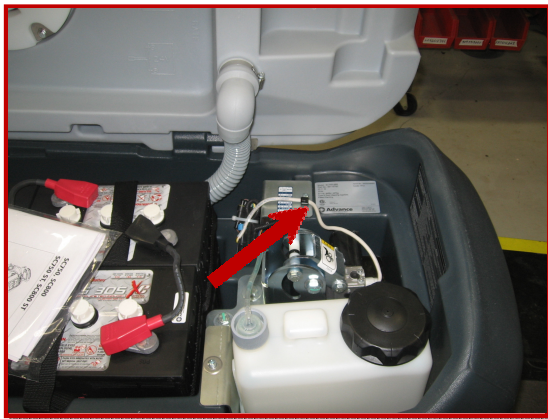
**Serial Number Tag Location  
SC750/SC800**

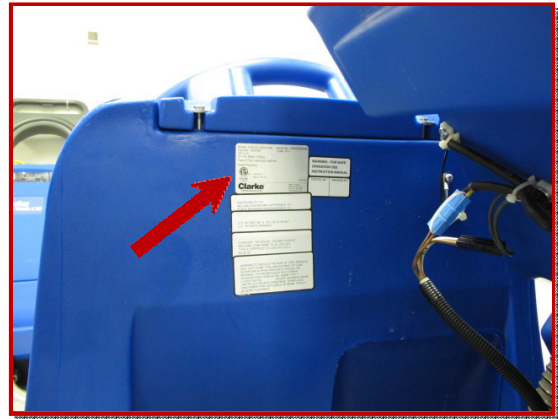
**Serial Number Tag Location Fo-  
cus II Midsize**

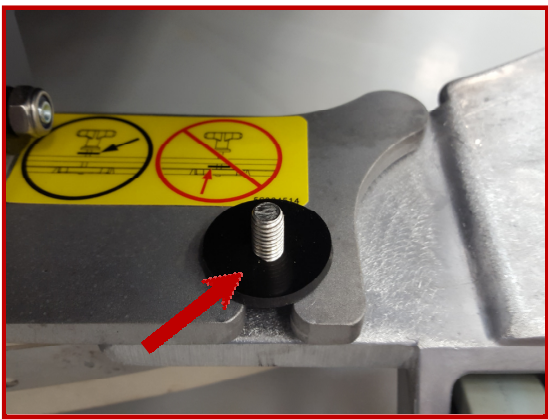
**Insert Nylon Washer Above  
Support Bracket**

Added Polyurethane Washer (PN 56384502) with an interference fit to the top of the squeegee support bracket (PN 9096045000) to enhance breakaway function. Changed from zinc plated squeegee bolt to stainless steel bolt (PN 56002884) SCR-HEX SS 5/16-18 X 1.25 on the SC750/SC800. Added decals to top of bracket showing correct washer position (see page 3 for location).

**FIELD CORRECTIVE ACTIONS:** On all machines make sure the black nylon washers, P/N 56384502 are placed between the squeegee thumbnut and the squeegee support bracket as shown on page 3.

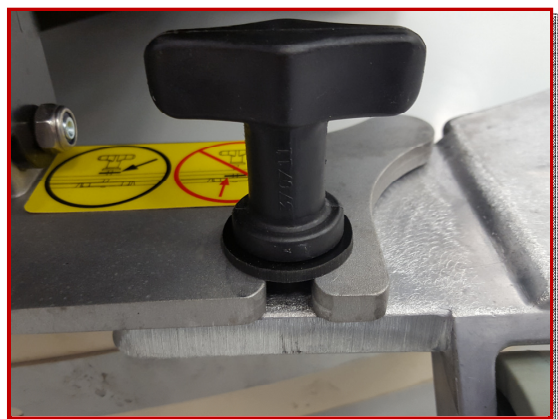
**Thumb Nut Installed  
\*\*DO NOT USE ANY TOOLS TO TIGHTEN\*\***

Squeegee thumbnuts are over tightened typically using a tool such as a pliers.

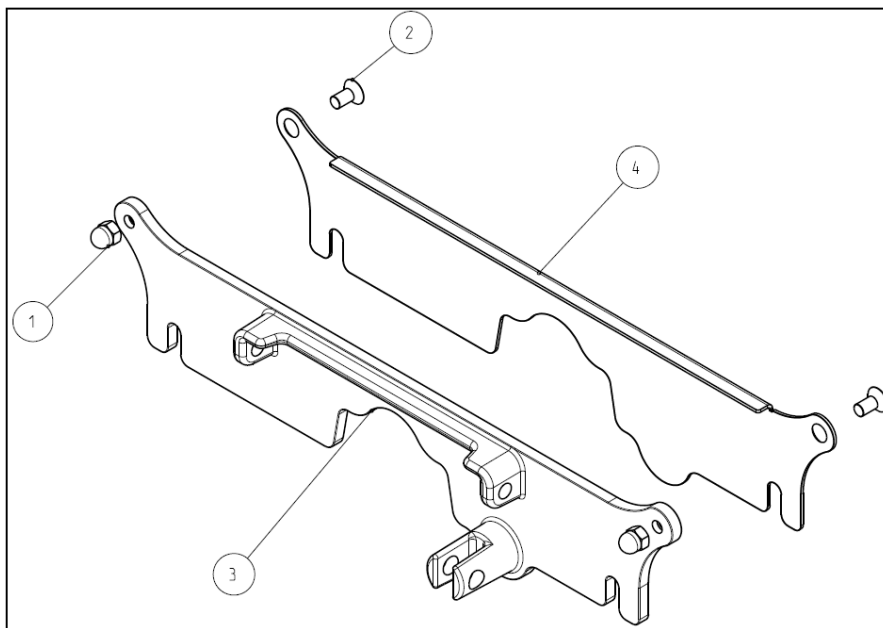
**9098912000** KIT, PLATE SQUEEGEE SUPPORT - To further strengthen the squeegee system for certain applications. (Shown below)

**ALTERNATIVE FIELD CORRECTIVE ACTIONS:** A SQUEEGEE SUPPORT PLATE KIT was also developed to further reinforce the squeegee support bracket for some environments.
