**Subject:** Squeegee Cable Kit Available

**Models Affected:** Focus II L17/L20/S20/BOOST L20

**Issue:** Premature failure of the squeegee cable where the cable is crimped to the threaded adjusting terminal. See Figure 1 below.

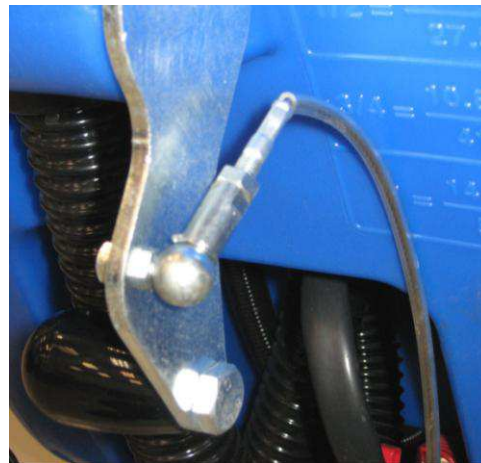
**Figure 2 – Cable Positioned Incorrectly**

**Cause:** Repetitive bending with the cable positioned incorrectly. See Figure 2 below.

**Corrective Action:** Factory: As of 2/10 and starting with machine serial number 100506384, the ends of the squeegee cables were reversed to avoid accidental bending (see Figures 3 and 4 on the following page).
