## Technical Service Bulletin

**MODEL(S) AFFECTED:** M20 (Serial Numbers 005700-014639)/T20 (Serial Numbers 005000-013710)/M30 (Serial Numbers 004000-010345) Equipped With Mitsubishi Gas/LP Engines

**SUBJECT:** Hot exhaust pipe can potentially touch lower radiator hose, causing heat damage to hose and possibly a coolant leak.

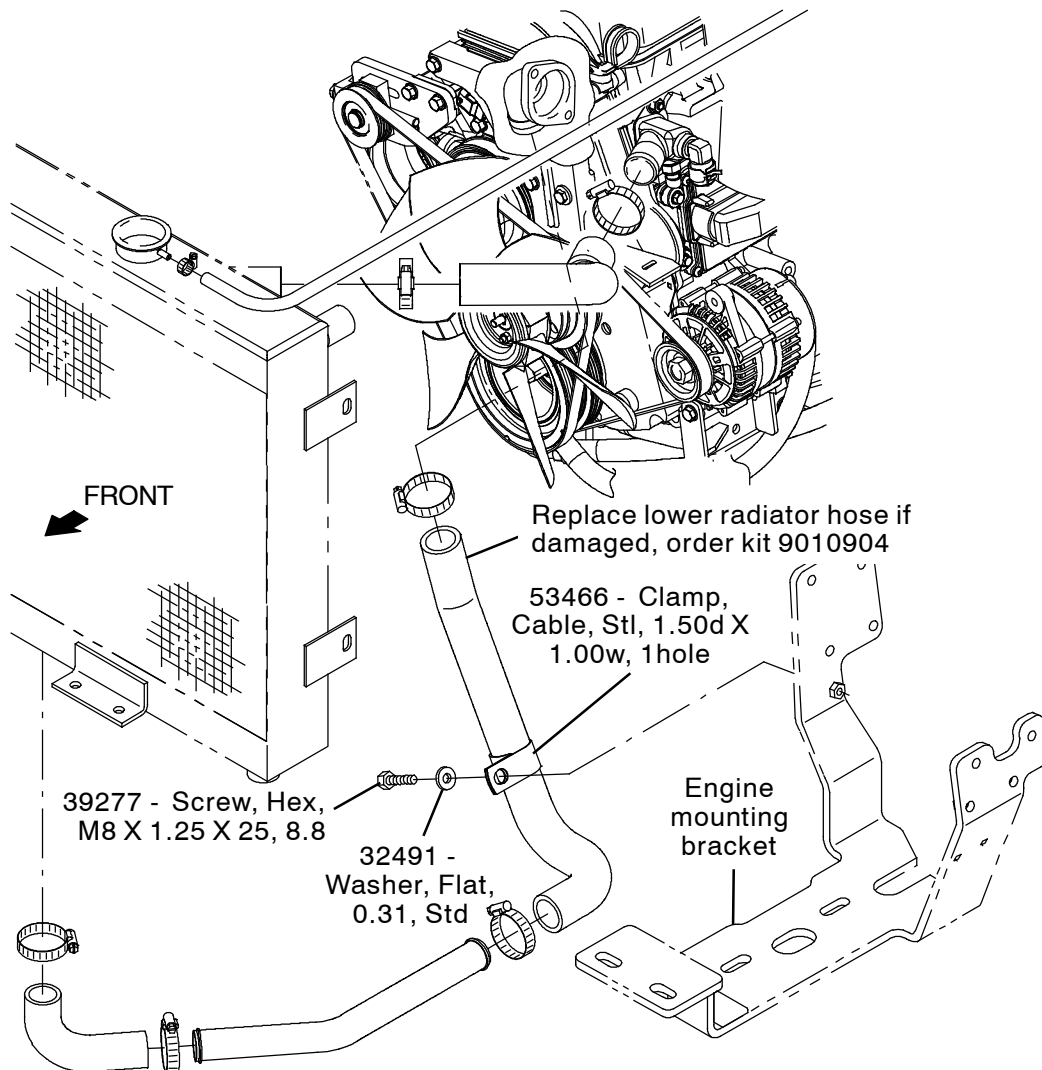
**NOTES:** Refer to IB 9010906 for instructions to access/replace the lower radiator hose/hardware. Parts required to secure lower radiator hose away from exhaust system listed/shown in diagram below. Questions, contact the Tennant Customer Service Department at (800) 553-8033/ TNV contact 0031 (0) 413241242.

**PURPOSE:** Install clamp to secure lower radiator hose to engine mounting bracket and away from the exhaust pipe. Replace lower radiator hose if damaged.
