Technical Service Bulletin

MODEL(S) AFFECTED: **T7 Rider Scrubber** - Models manufactured before serial number 10613731 (April 9, 2013).
Models manufactured in Europe before serial number T7xxx06952 (April, 2013).

SUBJECT: Potential drain hose damage due to careless machine operation when transporting with squeegee raised. If the right side of the squeegee assembly strikes a wall or obstruction with excessive force (see photos below), the left edge of the squeegee lift bracket will crush the drain hose causing damage and water leakage.

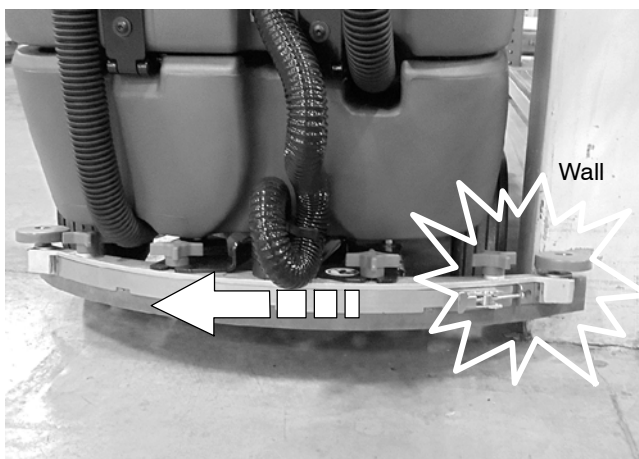
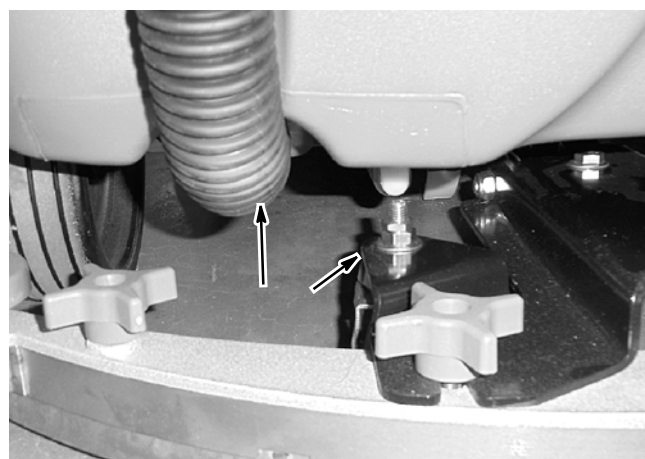
When squeegee assembly strikes a wall with excessive force, the left side of the squeegee lift bracket will crush drain hose.

PURPOSE: To prevent potential drain hose damage you have two options:

1. Install upgraded squeegee lift bracket (p/n 1018725) which is slightly smaller in width that will provide ample clearance if squeegee assembly strikes a wall or obstruction with excessive force.
2. As an alternative to replacing the bracket, install a longer piece of protective edging (p/n 1020168) on the existing squeegee lift bracket as shown below.
