# Nilfisk

## TECHNICAL SERVICE BULLETIN

**Number:** TSB-FC-2016-273 S7000 Main  
broom string guard

**Symptom:** Oil leaking from main broom gearbox

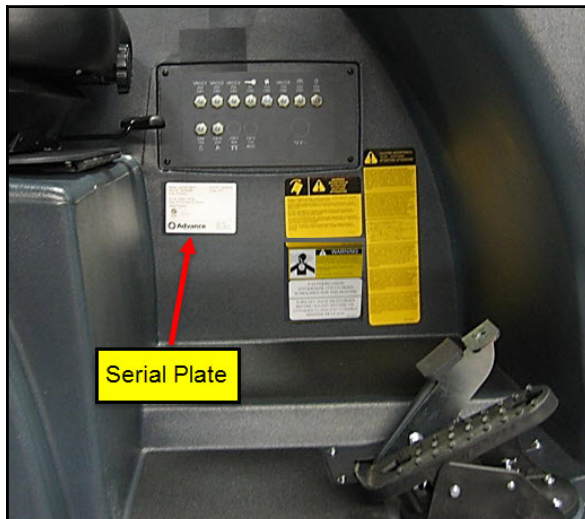
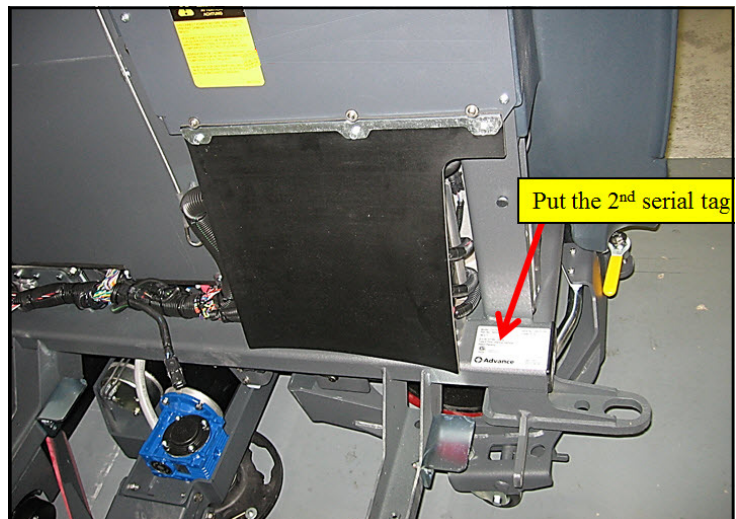
#### Serial Number Tag

The Model Number and Serial Number of your machine are shown on the Nameplate. One nameplate is located on the wall of the operator's compartment just below the circuit breaker decal. The second nameplate is located on the chassis beneath the recovery tank.
