# TSS Bulletin

Date 06-21-2012, Issue 29

## Purpose: Swingo 350B Recovery Tank Drain Plug Upgrade

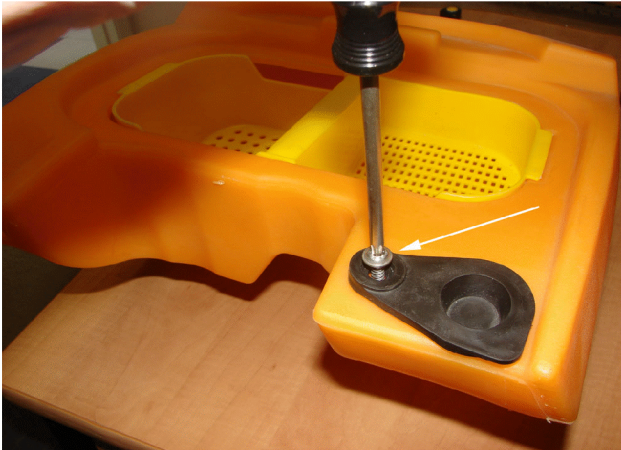
Step 1: Remove the screw from the drain plug using a Torx T-30. Set screw aside as you will reuse it.

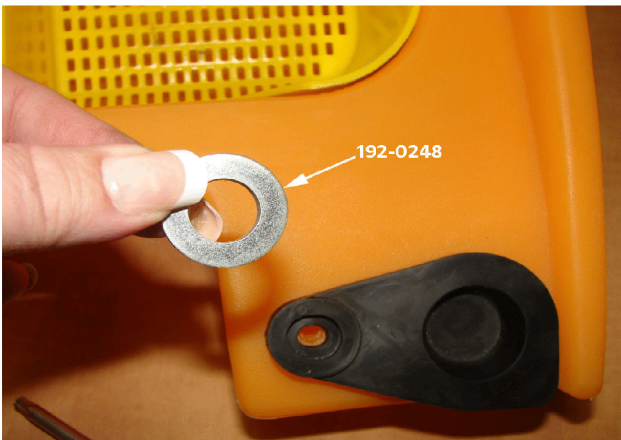
Step 2: Add the washer (part # 192-0248) to the drain plug.

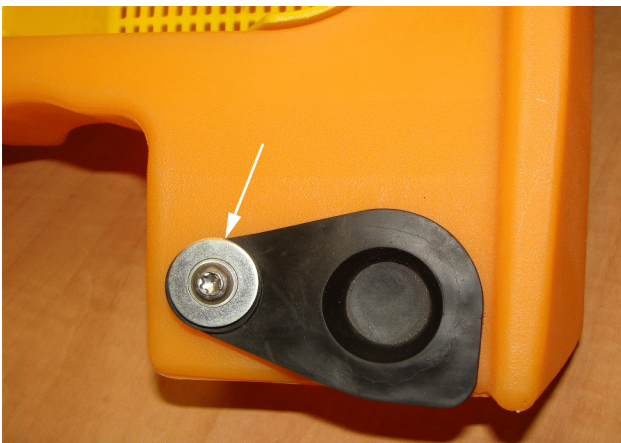
Step 3: Replace the screw using the Torx T-30.
