# TSS Bulletin

Date 06-22-2012, Issue 30

## Purpose: Swingo 350B Squeegee Support Bracket Upgrade

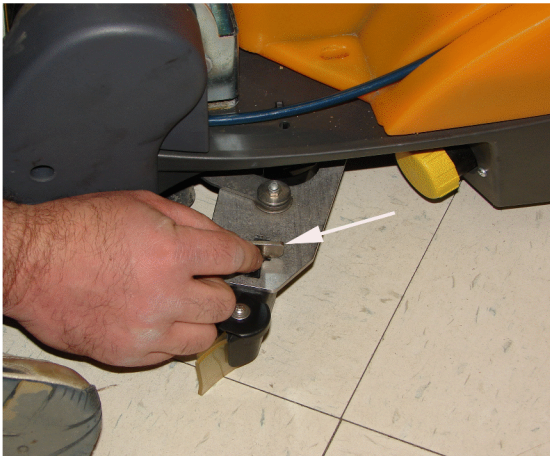
In some cases the squeegee thumb screw (see Step 1 below) has separated from the bolt and the squeegee blade cartridge will no longer be attached to the squeegee support bracket.

Step 1: Turn the 2 thumb screws until they're aligned with the slot on the squeegee support bracket. Remove the squeegee assembly from the machine.
