TECHNICAL SERVICE BULLETIN

Subject:	Vacuum Motor Connections
Product(s):	Condor BR1100/BR1300
System:	Recovery
Number:	TSB-FC-2013-116
Date:	18 JULY 2013
ODM/ECO:	A-08772
Urgency:	Level 2

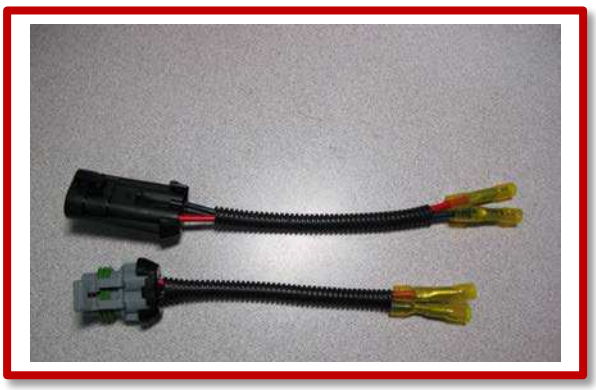
Poor connections at the vacuum motor to wiring harness interface

Poor fitment of the internal connections at the vacuum motor terminals

1. Order part numbers **56383234** CONNECTOR ASSY DUCON MALE and **56383235** CONNECTOR ASSY DUCON FEMALE
2. Cut off old connectors and discard, then splice new connectors into existing wiring
