# TECHNICAL SERVICE BULLETIN

# Nilfisk

**Number:** TSB-FC-2017-062

**Symptom:** Battery deactivated, 3 red flashes.

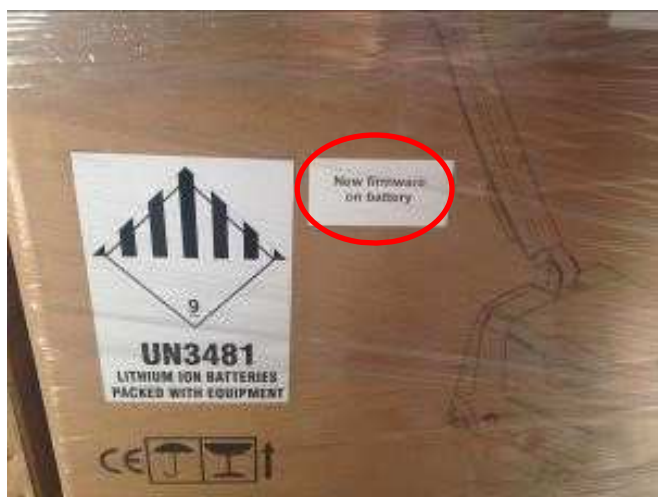
Identification label added on the machine box

Same PN's. Battery packs in production and DC's stocks are updated with new firmware.
