# Technical Service Bulletin

**MODEL(S) AFFECTED:** **T600/T600e/T600EE Walk-Behind Scrubbers equipped with membrane control panels**

**SUBJECT:** **Battery Discharge Indicator (BDI)** fails to display the LED rippling mode during the charge cycle. A recent User Interface (UI) firmware release has contributed to this behavior glitch.

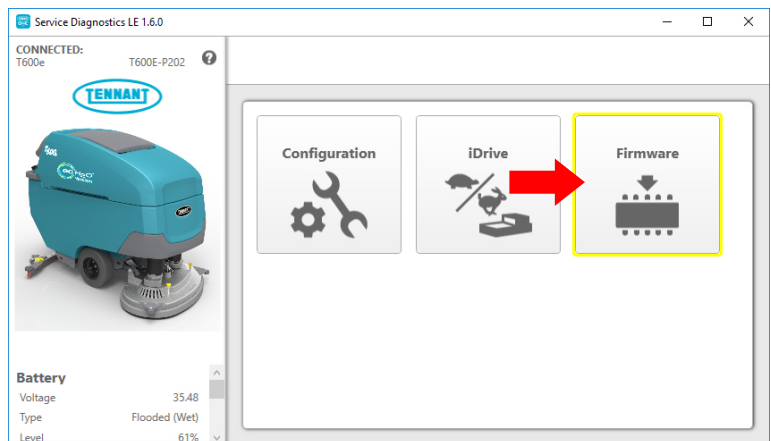
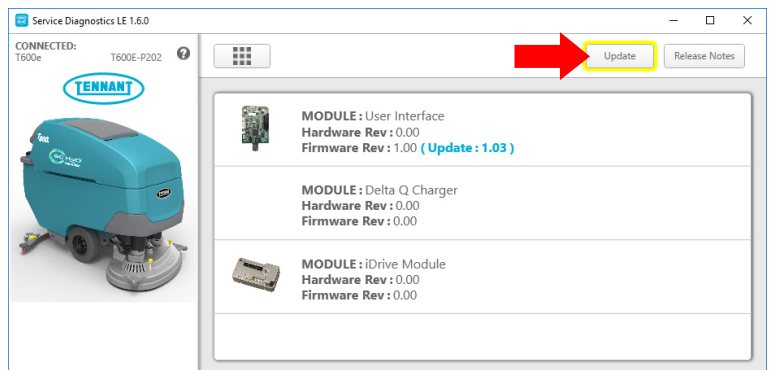
Using the latest Service Diagnostics software version, update the UI Firmware. (T600e model example shown below)

**PURPOSE:** To restore the BDI charge cycle behavior install the following User Interface (UI) firmware revisions as instructed below.

- T600 - UI Firmware Rev: 1.03 or later
- T600 Pro-panel - UI Firmware Rev: 1.04 or later
- T600EE - UI Firmware Rev: 1.03 or later
- T600e - UI Firmware Rev: 1.04 or later
- T600e equipped w/ IRIS - UI Firmware Rev: 1.9 or later
