# Troubleshooting/Replacing the Traction Encoder

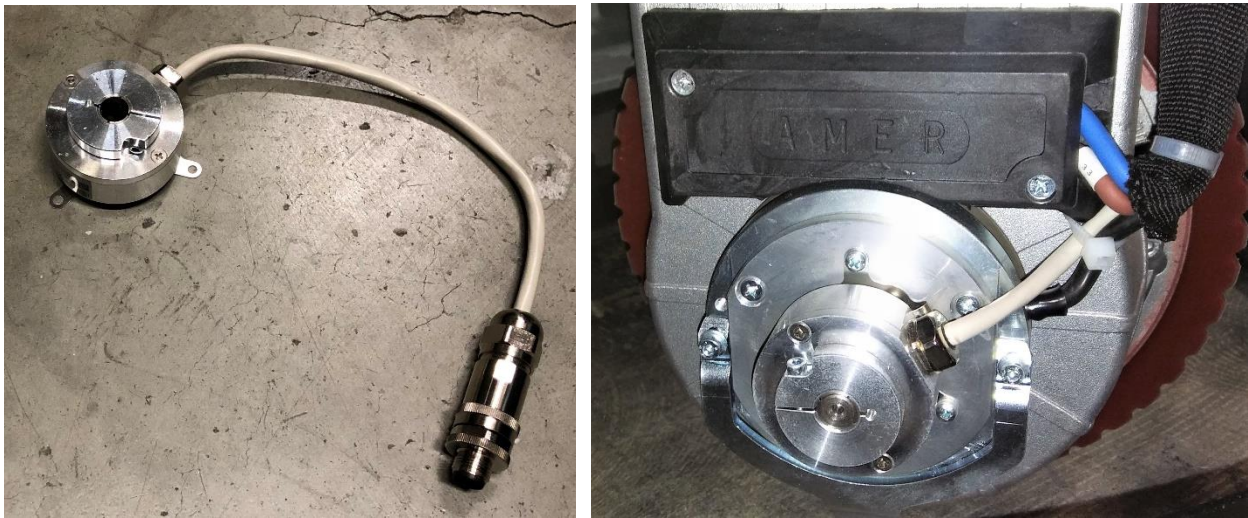
The Traction Encoder is responsible for tracking the movement (distance) traveled by the scrubber. As the traction wheel spins, the encoder counts ticks and relays that information to the robot, thereby quantifying and monitoring how much distance the scrubber has moved.

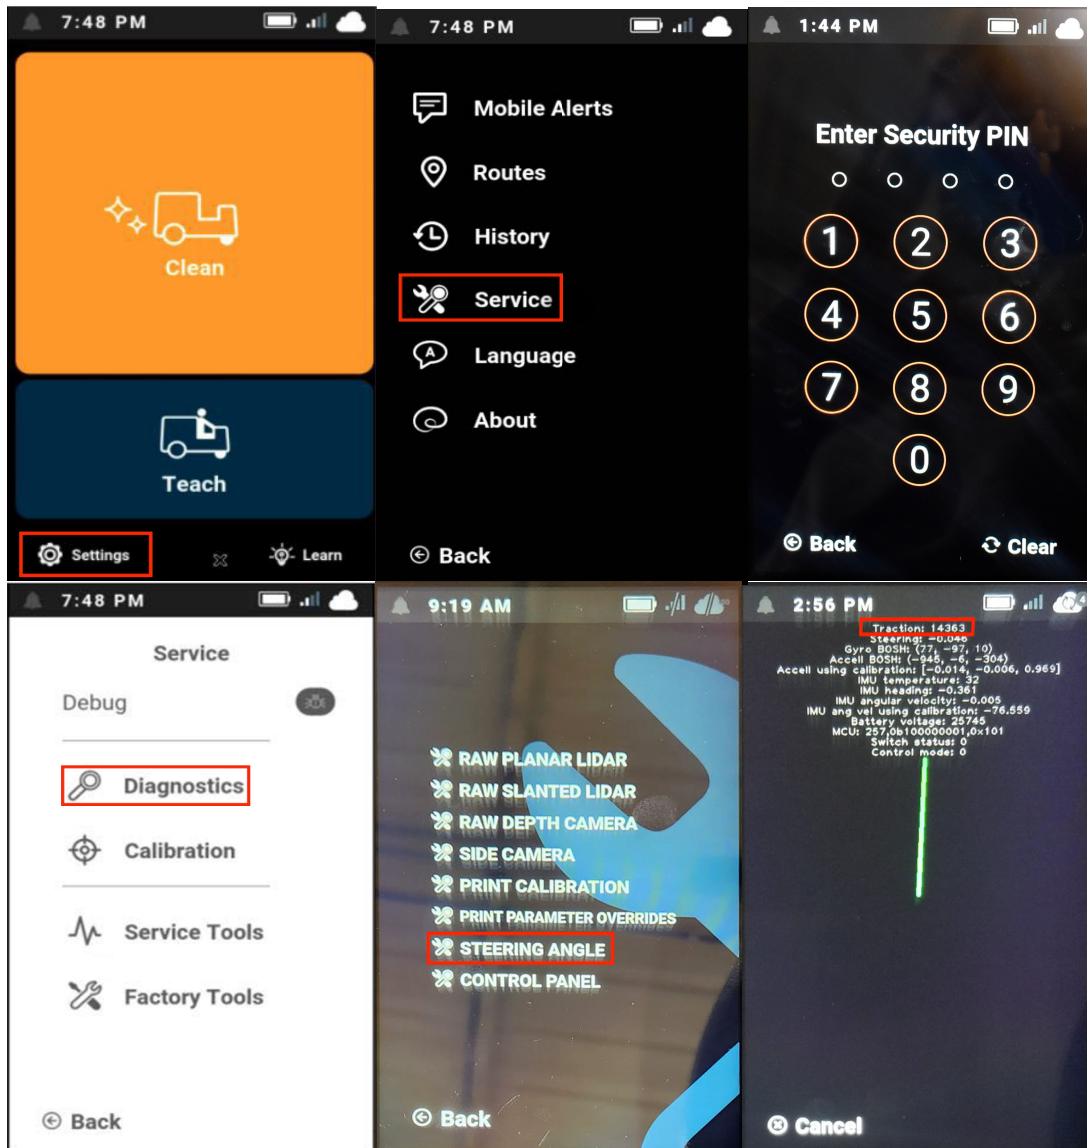
As the unit is manually driven forward and backwards, the Traction value should increase or decrease.

As the unit is manually driven forward and backwards, the Traction value should increase or decrease. If it does not, the following troubleshooting steps are recommended:
