**Number:** TSB-FC-2015-025 CS7000

**Symptom:** Squeegee will not lower– Error Code 39 on display

**Date:** 20th July, 2015

Electrical System — MAIN PCB BOX ASSEMBLY

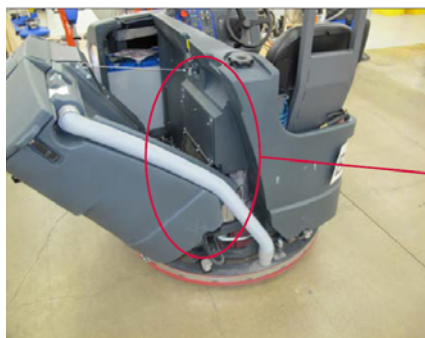
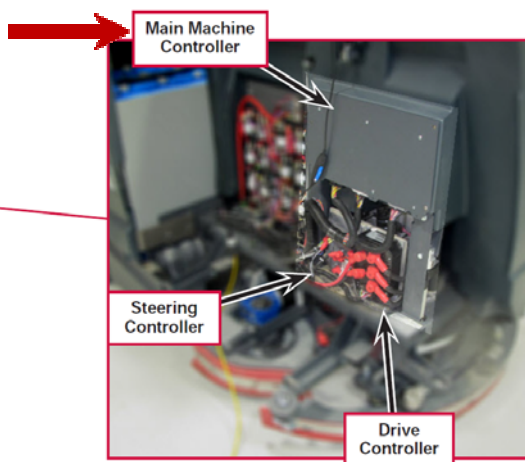
Fig.2

In some applications the main (PCB) control board squeegee actuator output may exhibit reduced life, especially if the actuator circuit is drawing excessive amperage. In some cases the internal actuator wires have been found shorting to the housing causing the circuit to overload.

Replace Main Control Board. Before installing new board, the wiring to the actuator should be checked for a short to the frame. The internal wires in the squeegee actuator should be inspected for a possible internal short to the housing. Remove the actuator cover and inspect the wires. See Fig.1 & 2

**56509247** ACTUATOR SQUEEGEE LIFT - If internal short is found or if actuator is drawing more than 5A while running
