# SC50 Autonomous System Error Codes

## Autonomy Firmware Revision: 9.4.3

# Autonomous System Error Codes

## Firmware 9.4.3 Autonomous

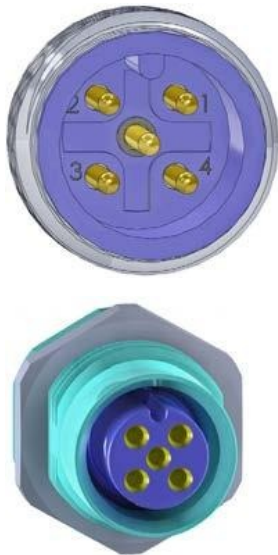
- If the voltage is not 24 volts, replace the autonomous module.
2. Laser module indicator lights are illuminated.
  - a. Disconnect the cable from both the autonomous module and the laser module.

- b. Check the continuity between pin 2 at both ends of the cable.
    - If there is no continuity, replace the cable.
    - If there is continuity, the fault lies with one of the two modules. Swap each module separately to determine which one is at fault.

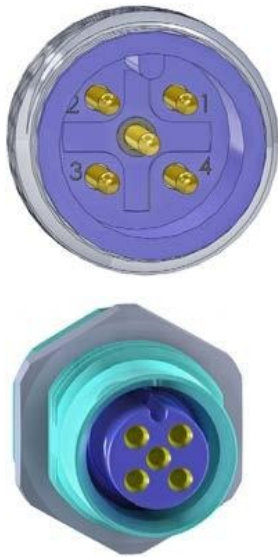
1. Disconnect and re-seat the power cable between the autonomous module and the laser.
  - If the indicator lights illuminate, reboot the system to validate the repair.
2. Disconnect the power cable at the laser module.
3. Check the voltage between pins 1 and 3 of the power cable (upper image).
  - If the voltage is at or near 24 volts, replace the laser module.
4. Disconnect the power cable from the autonomous module.
5. Check the voltage between pins 1 and 3 of the autonomous module (lower image).
  - If the voltage is at or near 24 volts, replace the power cable.
  - If the voltage is not 24 volts, replace the autonomous module.
