EQT0012

**Subject:** Genie APS Decreased Run Time

This bulletin is to notify you of a potential decreased run time on some models of E83039-00 Genie APS Automatic Scrubber.

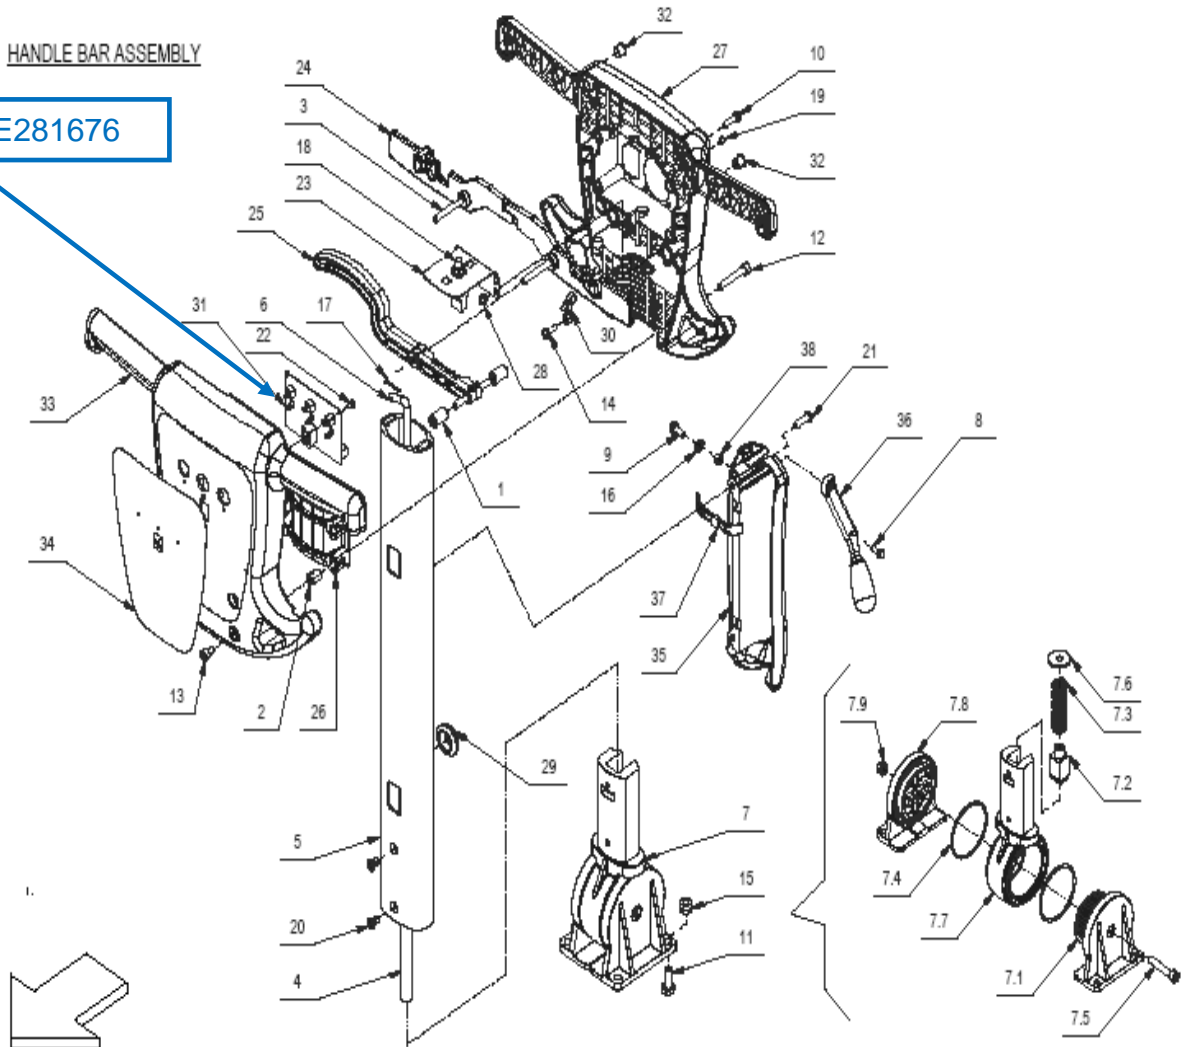
HANDLE BAR ASSEMBLY

## Electronic card (battery check card) location:

Ref#31 Part#E281676

The battery check card may be set incorrectly from the vendor on some machines. If incorrect, the battery check card will shut off prematurely. Please note that not all machines are affected. . Replacing the check card will allow the battery voltage to go down to the proper value before automatically shutting off the brush motor.

<u>Item ID</u>	<u>Description</u>	<u>Qty.</u>
E281676	Electronic Card, 12 volt	1
