| Machine | TASKI swingo 350B – 1255B |

Battery plug to be disconnected during storage and charging

GTS Newsletter

2017/10E

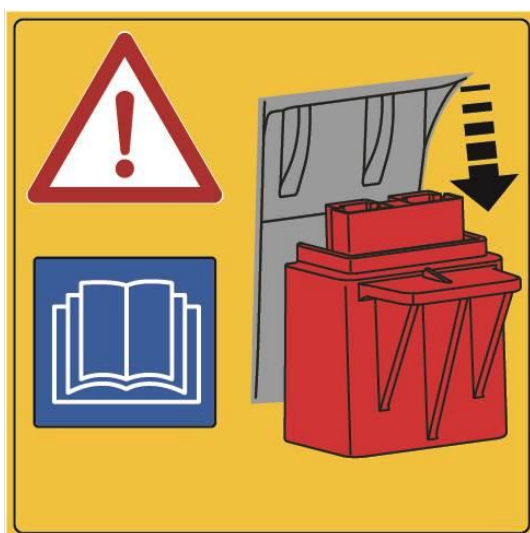
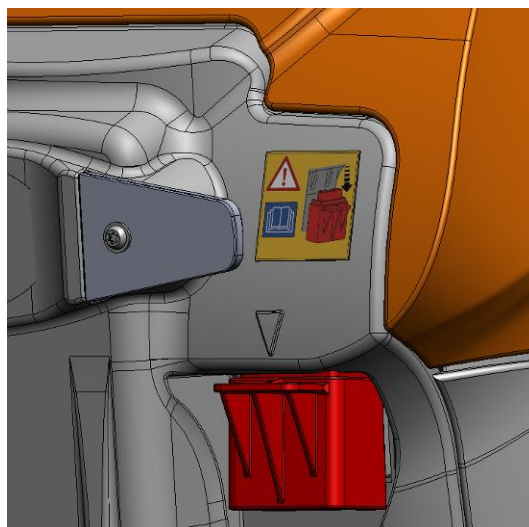
In order that the operator does not forget about it, a sticker which is showing the plug and referring to the user manual has been placed above the disconnecting plug. In the manual it is stressed out again in which situation the machine must be de-energized mandatorily.

Please advise our customers to follow this instruction.

Please place the sticker during the next service.
