| <b>Machine</b> | <b>TASKI swingo 350E</b> |

## New hose for water regulation

TASKI swingo 350E

as of machine number 9828

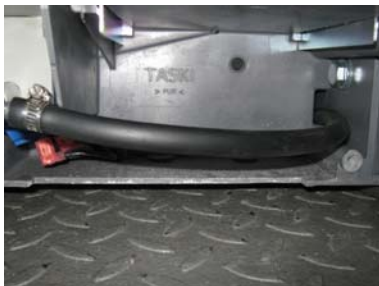
Up to now a PVC hose has been used for the water flow in the machine. We have received increased feedback that the hose remains squashed at the water control valve and therefore it only allows a minor flow rate.

New hose EPDM placed in the machine

With immediate effect a hose made out of EPDM will be inserted. The hose remains stable in its form even after a longer time of being squashed and assures therefore the adjusted water flow rate.

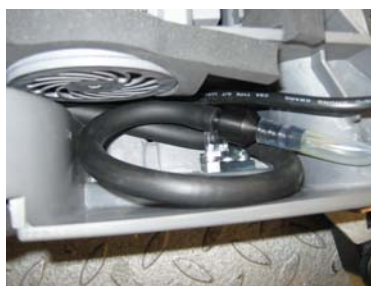
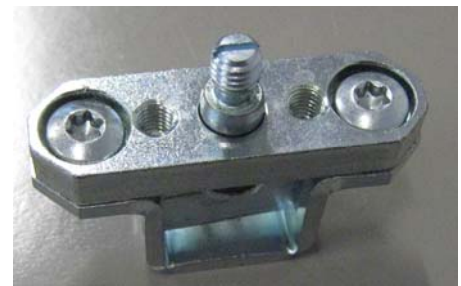
New regulation system

As the new hose has different measures the complete regulation system has to be replaced in order that the EPDM hose reaches the same max./min. flow rate. The star knob most probably gets destroyed when dismantling the bracket as the same is fixed with securing adhesive (Loctite) on the spindle.
