# GTS Newsletter

2013 / 25E

| <b>Machine</b> | <b>TASKI swingo 350E, 455E</b> |

## Switch protection

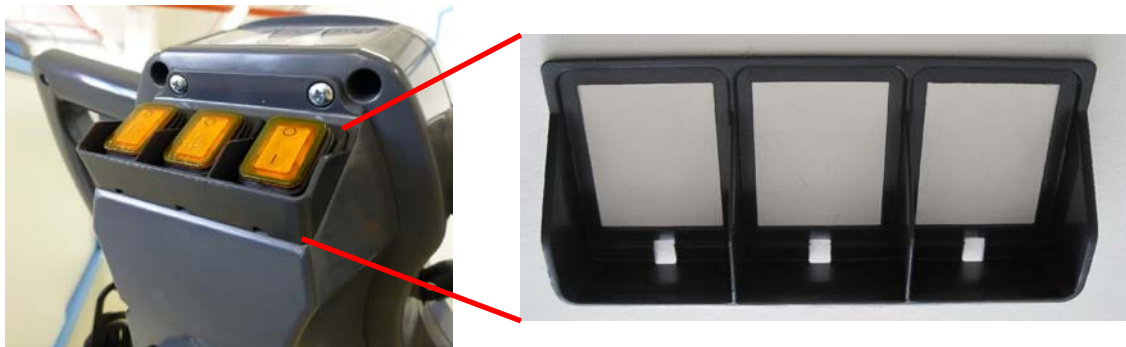
Increased demands of rocker switches have lead us to analyse this issue in detail. On returns and defective samples it could be determined that the mechanism within the switch was unhinged. Internal tests have shown that this can happen if the handle bumps against an obstacle with high force.

To improve the protection of the switch an additional cover will be mounted with immediate effect.

| Description | Material number | Remarks |
|---|---|---|
| Cover | 4130964 (14620-68) | Existing spare part number |

We recommend carrying out this modification for customers which repeatedly complain about failures.
