# GTS Newsletter

2009/02E

| <b>Machine</b> | <b>TASKI swingo XP</b> |

## New tank cover TASKI swingo XP

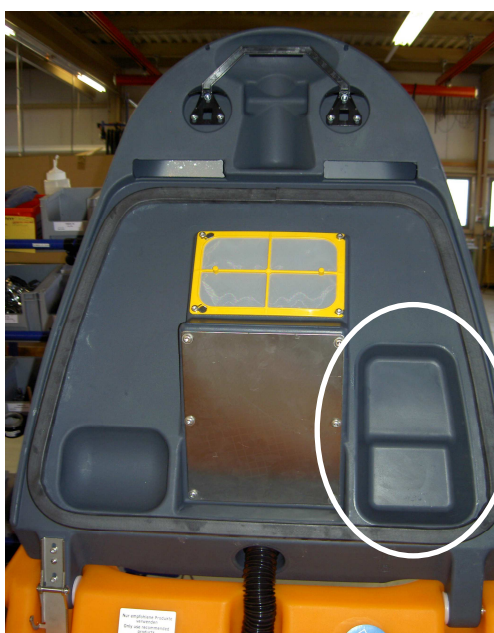
Due to increased feedbacks from the field that the fresh water suction hose in the area of the flex tank support (metal frame) got damaged, we have adjusted the shape of the tank cover (white marking). As a result of this modification the hose has a wider space for movements, which is preventing injuries by squeezing and rubbing on the metal frame.

The new tank cover is reverse compatible and can be ordered under the existing material number 4124371 (18600-89)

Proactively exchanged tank covers will not be reimbursed under warranty.

as of machine number 2981
