# GTS Newsletter

2009/09E

| <b>Machine</b> | <b>TASKI swingo XP</b> |

## Linear drive Brush unit

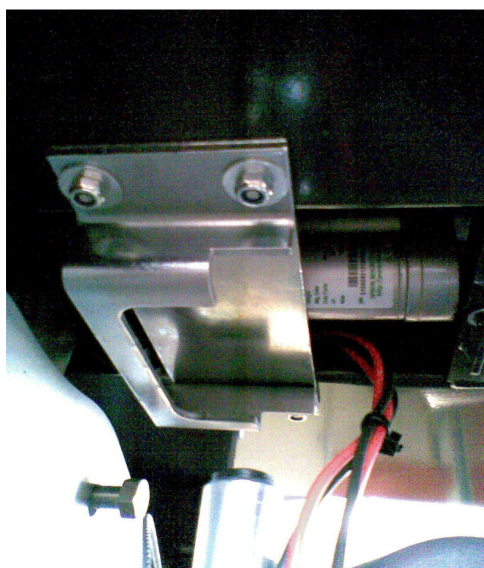
Picture from underneath

4 holes, Ø 7mm (according drawing) have to be drilled into the chassis to complete modification.

The fixations of the new parts have to be secured with thread locker 4017370 (8936/1).

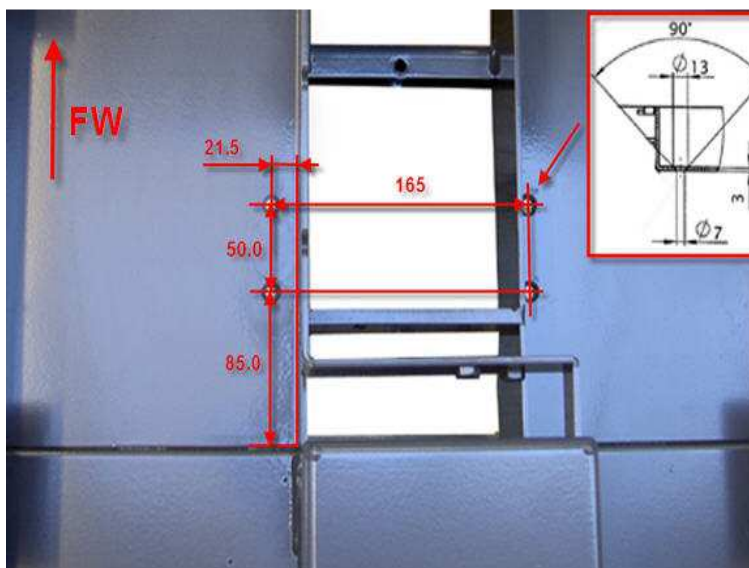
Picture from above (incl. dimensions)

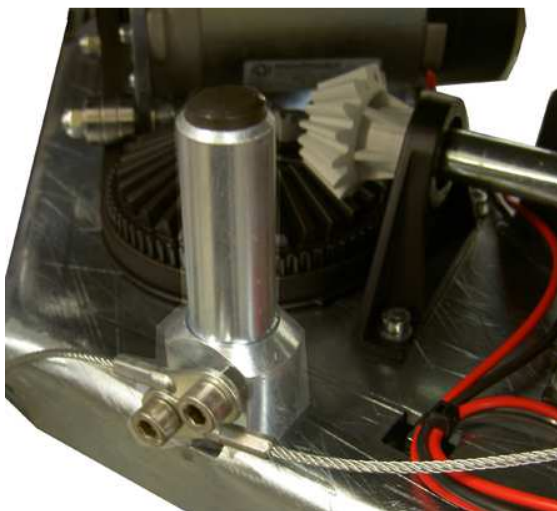
Guidance bolt fixed to motor base plate

To assemble the bolt on the motor base plate the original hole has to be enlarged up to 11 mm.

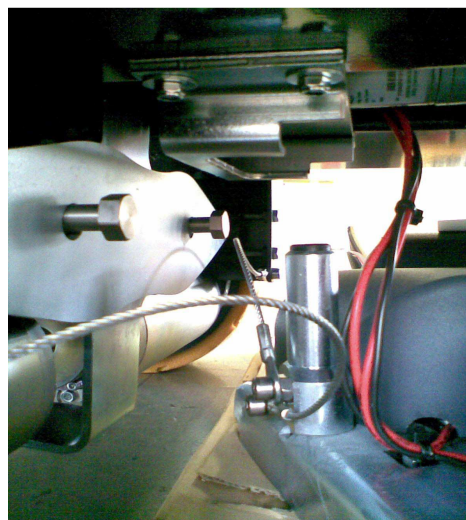
Picture of complete modification

We recommend implementing the modification kit when the linear drive has to be replaced.

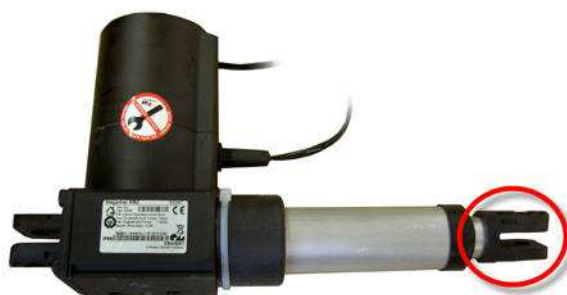
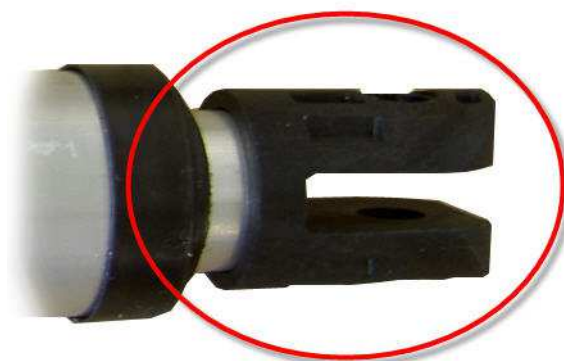
## Fork head

Due to an increasing number of linear drive orders, as well as feedback from the field regarding broken fork heads, we introduced a modification kit for the chassis/brush unit. Additionally the fork head is now available as single spare part.
