# GTS NEWSLETTER

## TASKI ergodisc 165/200/300/400/Duo Subassembly: Drive

*Replaces GTS Newsletter N2004/04*

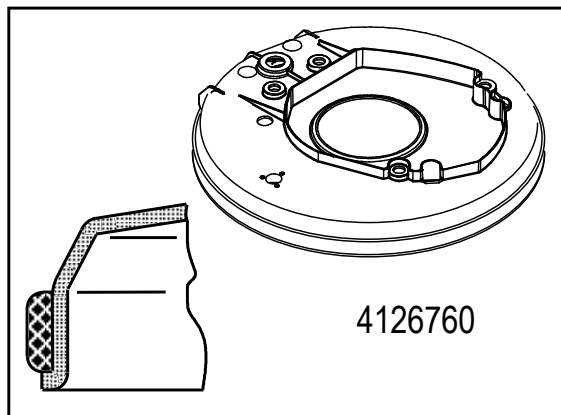
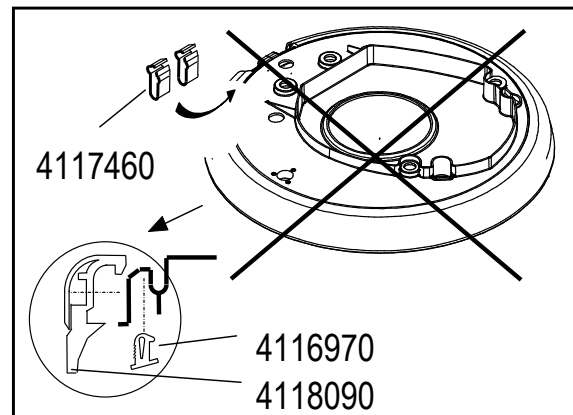
The actual mounted brush housing will be replaced by a new, strengthened brush housing which has an integrated, stuck bumper profile (see drawing LH).

- All ergodisc models (Ø 43 cm) can be retrofitted with the new brush housing
- With immediate effect, only new brush housings are delivered
- The covering profile and the supporting clamp set are still available

Old	New
<b>Brush housing</b>	4122576 (14604-33)	replaced by 4126760 (14604-46)
<b>Bumper profile</b>	4118090 (14600-97)	not anymore available
<b>Covering profile</b>	4116970 (8662/008)	still available
<b>Supporting clamp set</b>	4117460 (14604-19)	still available
