# Nilfisk

## TECHNICAL SERVICE BULLETIN

**Number:** TSB-COM-VAC-2015-002

**Symptom:** Wheel spare part kit for VU500

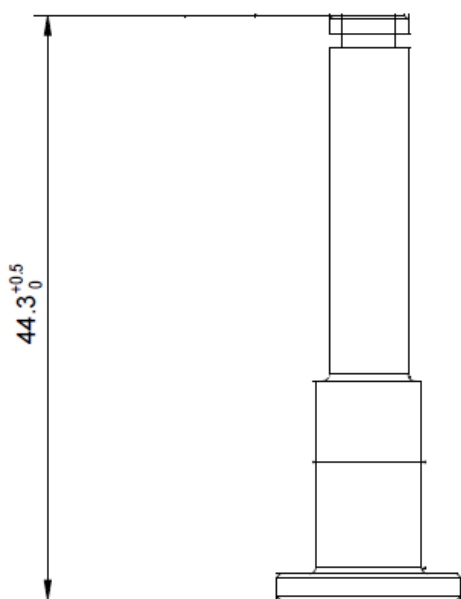
Correct for VU500:

**Correct spare part for VU500:**

107416451 WHEEL SHAFT KIT

New shaft wheel kit 107416451 has been created including a longer shaft that fits VU500.

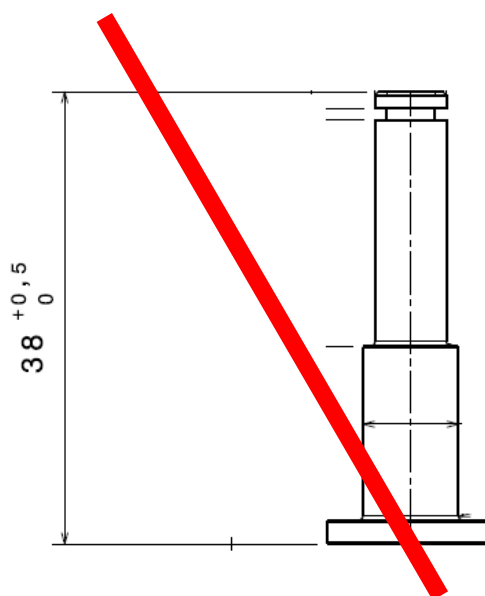
Wrong for VU500:

The wheel shaft in spare part 147 0898 500 is too short for the VU500.

Spare part lists was referring to the wheel shaft kit for GU 305/355/455 and Spectrum upright vacuum cleaners. The shaft in these kits are shorter then the one used in VU500.
