TECHNICAL SERVICE BULLETIN

Number: TSB-FC-2015-044 SC750/800 IC650
Charger Interlock

Symptom: Machine failed to turn on

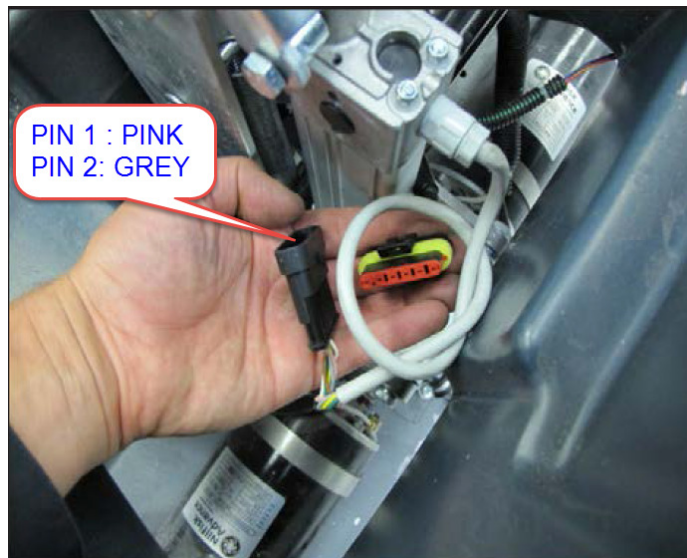
FIG. 1

If the charger interlock circuit has failed, please check the amp draw of the actuator installed in the machine to verify the actuator and linkage are functioning normally. Please test the amp draw of the actuator when jumped directly to the battery. It should be drawing between 2 -3 amps when raising and lowering. Pin1 and Pin 2 of the actuator connector are for the motor (FIG.1). Reverse polarity to change direction.
