# Nilfisk

## TECHNICAL SERVICE BULLETIN

**Number:** TSB-FC-2016-269 CS7000 Shaker  
motor ground connection

**Symptom:** Inability to remove shaker frame  
assembly

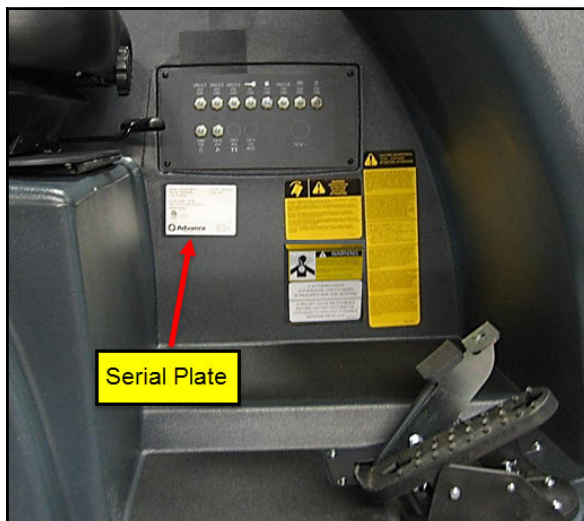
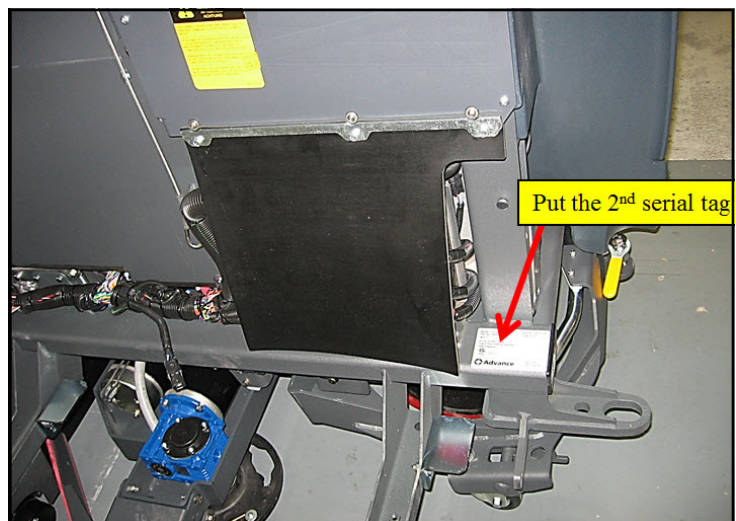
**Serial Number Tag**

The Model Number and Serial Number of your machine are shown on the Nameplate. One nameplate is located on the wall of the operator's compartment just below the circuit breaker decal. The second nameplate is located on the chassis beneath the recovery tank.
