Nilfisk TECHNICAL SERVICE BULLETIN

Number: TSB-FC-2018-003 SC900 Travels forward on its own

Symptom: Machine continues to travel forward on its own after releasing the buttons

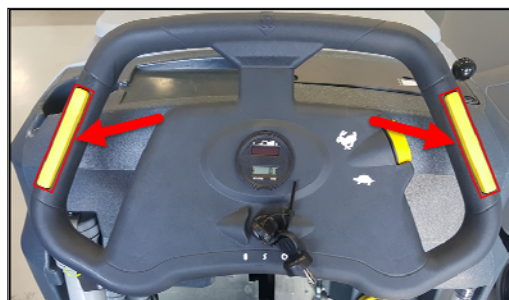
After releasing the left or right BUTTON-GO-YELLOW, the machine may continue to move forward on its own.

The two BUTTON-GO-YELLOW each hold micro switches that are activated when the button is depressed. In some cases the switch pocket and retaining latch do not hold the micro switch in place so the switch does not retract with the button when the button is released. When this happens the switch can remain in the "on" position after releasing the yellow go button. This can also happen if the wires to the switch do not have enough slack.

Redesigned the switch pocket and latch for improved switch retainment, increased the spring strength and improved the harness routing.

Order and install the CONTROL SWITCH/BUTTON kit to correct this issue with the forward switches sticking.

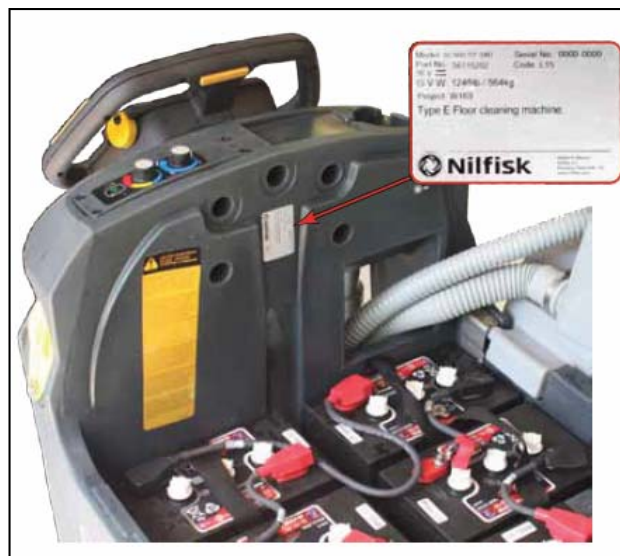
Serial Number Location

Serial Number: 4000166277

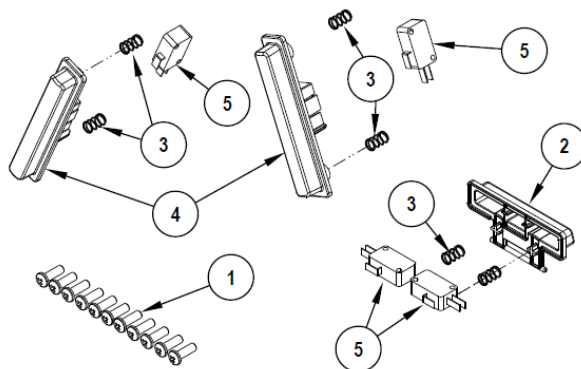
56115479 SWITCH / BUTTON KIT

Item	Ref. No.	Qty	Description
[]	56090353	1	Instruction Sheet
1		11	Scr. Pan Phil Plastite 10-14 x .62
2		1	Yellow Reverse Button
3		6	Spring-Compression-6.5 Pound
4		2	Yellow Go Button
5		4	Switch, Spot Snapaction
